Failure of temporary clamped joint under traffic

Ref: NRA 17/02

Location: Acton Central Level Crossing, Anglia Route

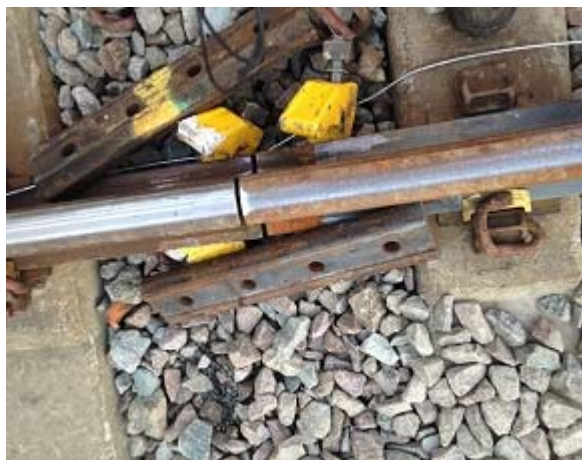
A member of Network Rail track staff who responded discovered that the clamps and fishplates had fallen from the rail joint leaving the ends of the rail unsupported.

The nylon insert in the nuts, intended to act as additional friction to reduce the risk of the joint undoing, was damaged. This appears to have occurred when the bolts were initially tightened and the nylon insert was pushed out of the nut.

- All clamps Type 'B', 109 / 110A / 113A & CEN 60 E-1 (UIC60) FB, for temporary joints / rail defect clamping with product catalogue number 0057/054321 shall be inspected prior to their next use.

- The visual inspection should focus on the straightness of the bolt and in particular the condition of the nylon insert in the nut.
- If on inspection, the bolt is visibly bent or the nylon insert on the outer end of the nut is found to be damaged or displaced the clamps MUST not be used and shall be taken out of service until the nut, bolt and washer are replaced.

- For replacement bolts use product catalogue no. 0057/150028. BOLT S&C, ROUND NECK, INCLUDING LOCKNUT AND WASHER 1" DIA X 290 MM U/HD, 90MM THREAD BS 64 (1992) HIGH STRENGTH.

- Each clamp must be assembled using components from a single supplier only. DO NOT MIX individual components from each supplier when constructing a temporary joint or clamping a defect. The pair of clamp bodies should be kept as a set and not replaced or reassembled using different components.
