Safety Advice

Cotec C31 Live line indicator

Ref: NRA20-09

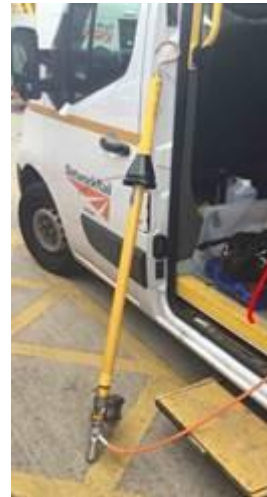
A recent incident involved a Cotec C31 Live Line Indicator (LLI) - Cat No 091/012337- which was damaged when used on live overhead line equipment (OLE).

An investigation of the incident concluded that the user screwed the contact hook directly into the body of the LLI and not into the (resistor) probe section. This subjected the body directly to 25kV causing it to fail and resulted in sudden movement of the tester.

- Users of the Cotec C31 LLI must be trained with their set up and use prior to using them.
- The contact hook must only be connected to the probe and never connected directly to the main body of the LLI.
- The earth lead of the Cotec C31 LLI must always be connected to the traction return rail prior to use.
- Never raise the LLI so that the fluorescent yellow band (just above the black rain hood) goes above the contact wire. This would risk operator injury and LLI damage.
