Safety Advice

Defective hand grip on Jafco Controlled Keying Hammers

Ref: NRA24-03

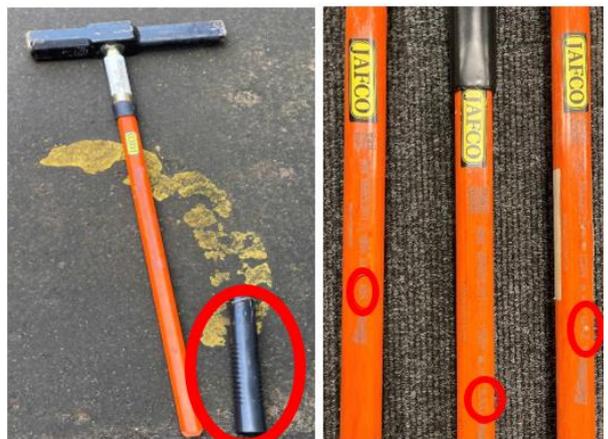
Due to a change in manufacturing process, the rubber hand grip on these two keying hammers, manufactured after July 2023, are not bonded to the fibreglass shaft.

Users have reported that these hand grips can become detached in normal use.

This could result in the hammer injuring or striking people and / or equipment if it becomes detached.

The hammer pictured in Fig 01 shows a detached hand grip.

- The 3-letter batch code on the fibreglass shaft (See Fig 02 circled in red) needs to be checked and if they correspond to the defective batches listed below, they should be removed from use immediately.
- Brief your work & stores teams about this defect and ensure appropriate checks are completed.

- All users need to check their tools before use to see if the rubber hand grip is either loose or not properly bonded to the handle.
- Defective hammers should be returned by contacting the Helpdesk and new replacements can be ordered from iStore.
