# Safety Advice

## Stressing Equipment Failure - Enerpac RP70AE100

Ref: NRA24-07

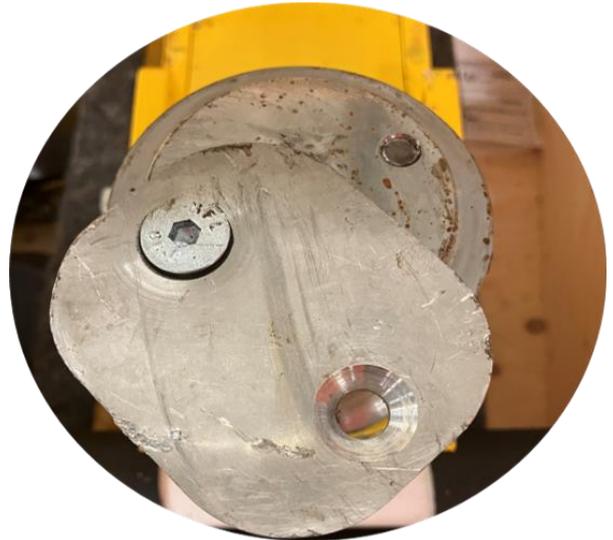
During the activity a retaining bolt sheared off on the Enerpac RP70AE100 stressing kit and a member of the welding team staff was struck by an extension strip of the kit, causing minor injuries.

- RP70AE100 equipment cannot be used on curves of radius less than 250m
- Inspect the locating brackets on the Enerpac stressing equipment.
- Checking that the equipment's inspection tag is in date.
- Check that the equipment is set up and used in accordance with the manufacturer's operating instructions.
- All staff **MUST** be competent and hold the familiarisation training specific for the equipment.
- A minimum 20m Exclusion zone for others not involved in the activity must be established and supervised.
- Where available the Remote Pendant must be used and the operator located a minimum of 3m away.
- Where a Remote Pendant isn't available, the equipment operator must be positioned a minimum of 3m away.
- Halt pulling operations when inspecting the welding gaps.
