# Safety Alert

## Foxton near miss

Ref: NRX20-01

Location: Foxton, Anglia Route

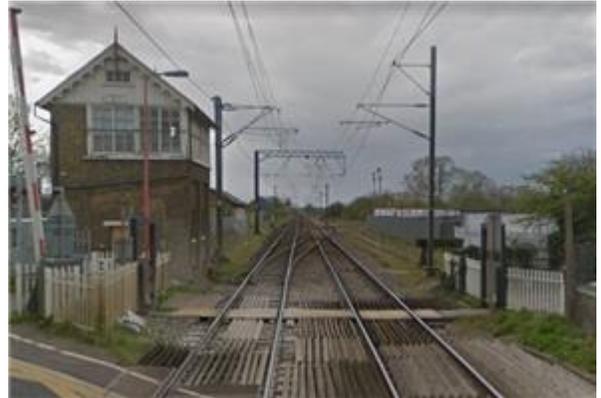
At 11:01am on 14th February 2020 a Network Rail track worker from Tottenham Delivery Unit had a near miss with a train. The person was part of a track team working on a reported defect on the Down line at Foxton.

9S25, a GTR service from Cambridge to Brighton was travelling on the Up line through Foxton station. The driver saw a track worker in the four foot of the Up line who was not moving to a position of safety. Another train was approaching on the Down line. The rest of the track team had safely moved to the Down cess.

The train was travelling between 70mph and 80mph toward the worksite. The track worker reacted to the approaching train when it was six seconds away and reached a place of safety with just three seconds to spare. This event constitutes a significant near miss.

- If all other options have been explored and unassisted lookout warning must be used, how do you test the Safe System of Work?
- How do you make sure you have a designated position of safety?
- How do you monitor sites to make sure people are following the Safe System of Work that has been applied?
- What should a Person in Charge (PIC) do if people want to move to a place other than the specified position of safety?
- How should the PIC agree what will happen and how people will remain protected?
