Safety Bulletin

Runaway trolley

Ref: NRB 17/15

Location: Baschurch, Shropshire

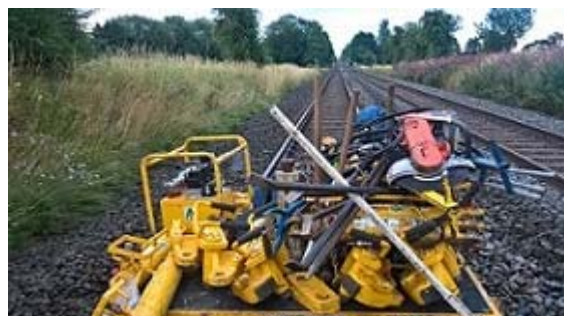
The initial report indicates that the trackman pushing the trolley lost his grip on the trolley as it began to increase speed while descending a gradient.

The handle used on the trolley was from a track jack and not the correct handle for the trolley and it is thought that the handle is of sufficient weight to prevent it returning to the vertical position when released, as it should to activate the brakes.

Nobody was injured but the trolley travelled over a mile before coming to rest. The project has halted all works with on-track trolleys until the investigation is complete and the cause is fully understood.

- Is the use of a track trolley the most suitable equipment for the task being undertaken?
- Have you ensured that any trolley being used complies with NR/L2/RMVP/0200/ module P513 (Issue 3)?
- How do you make sure that you always use equipment that is fit for its intended purpose?
- How do you load trolleys and how would you know if it is overloaded?
- How do we plan to make sure there are sufficient people on site to manage a loaded trolley?
- Do all trolley operators fully understand their duties and what checks they must make before setting off?
