## Safety Bulletin A serious incident has taken place

## Securing materials for the passage of trains

Issued to:	All Network Rail line managers, safety professionals and RISQS registered contractors
Ref:	NRB 18/13
Date of issue:	30/08/2018
Location:	Multiple locations
Contact:	Matthew Lane, HoRSHE Wales

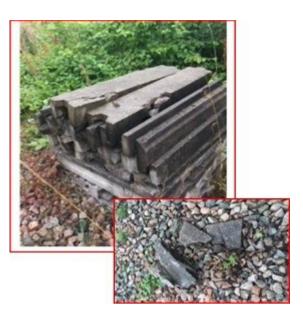
These include an incident at Barton & Broughton in Lancashire where an AWS unit lid that had been removed for maintenance work had not been safely secured and was dislodged by a passing train, and earlier incidents involving <u>plant</u> and equipment stored in tunnels. More recently, on 18 August 2018 a report was received from a driver that their train had jumped slightly when it came into contact with an obstruction and sustained minor damage near Tir-Phil station in Wales.

Subsequently a pallet of loose troughing bases and lids were discovered track side. The troughing bases used, potentially by a trespasser in this incident, would most likely have been taken from the pallet.

The pallet of troughing bases have now been banded and arrangements have been made to remove the material from site.
