Safety Bulletin

Train and tractor collision

Ref: NRB 16/07

Location: Hockham Road UWC, Anglia Route

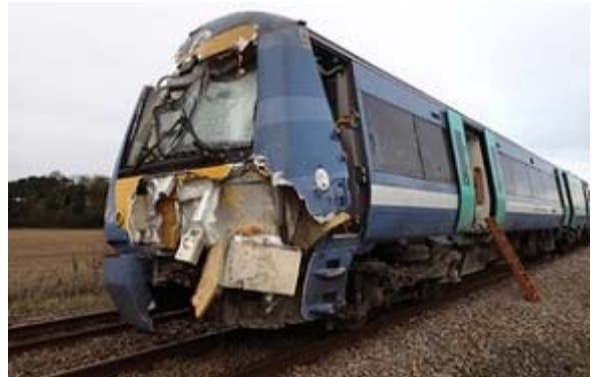
On Sunday 10 April 2016, the 12:04 Norwich to Cambridge service collided with a tractor at Hockham Road user worked level crossing near Thetford in Norfolk.

The train sustained significant damage especially to the driving cab, but did not derail. The tractor driver was airlifted to hospital after being ejected from the tractor and suffering multiple fractures. The train driver had cuts to his hand but escaped more serious injury by leaving his driving position before the impact. Four of the 135 passengers on board the train suffered minor injuries as the farm machinery subsequently collided with the side of the 3-car train.
