# Safety Bulletin

## Lifting Incident

Ref: NRB22-10

Location: Gatwick Station, Southern region

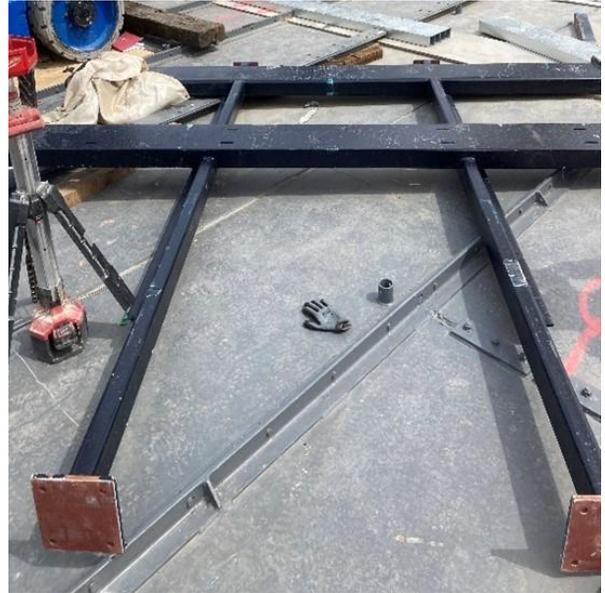
During the final lift, ahead of the possession, the connection plate at the foot of a glazing frame weighing approximately 500Kg became caught on the underside of a movement joint which was approximately 65mm above the deck.

This resulted in the glazing frame turning and the lifting strop supporting it rapidly snapping due to the continued force from the crane.

This caused the frame to fall which resulted in fatal injuries to the Slinger Signaller.

Lifting operations are adequately planned and associated lift plans clearly identify:

- o Methods of slinging
- o Exclusion Zones
- o Where people are positioned during lifts

The hazards presented by the immediate environment

The lift plans are understood and being worked to, consider:

- o Levels of supervision during lifting
- o How you test for knowledge to ensure understanding?
- o Do you have the right levels of assurance in place?

**Reinforce the message that if the lift plan cannot be worked to, things change, or it is not safe - STOP WORK**
