Safety Bulletin

Serious injury at Clapham Junction

Ref: NRB24-02

Location: Clapham Junction, Southern Region

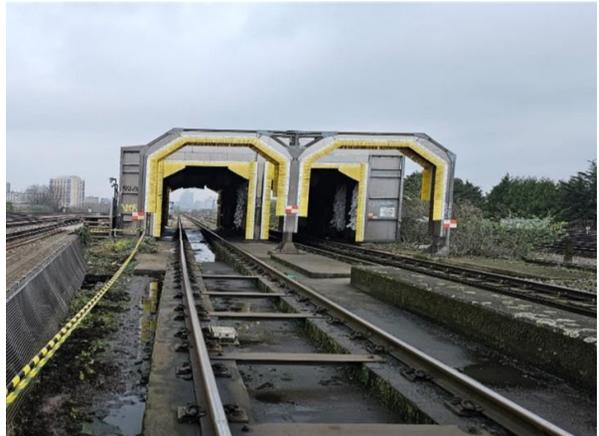
The contractor was undertaking maintenance activities and was fitting low-level overspray brushes onto the carriage wash. The injured person (IP) was standing on a wooden infill adjacent to the bridge parapet. While using the structure of the bridge as a workbench, the infill gave way causing them to fall through and land approximately 20 feet below onto another railway line (which is operated by a different route/control (which was operational at the time.
