# Safety Bulletin

## Aspen Hi-Flow Condensate Pump Burn Out

**Ref:** NRB25-03

**Location:** Warrington PSB Telecoms room

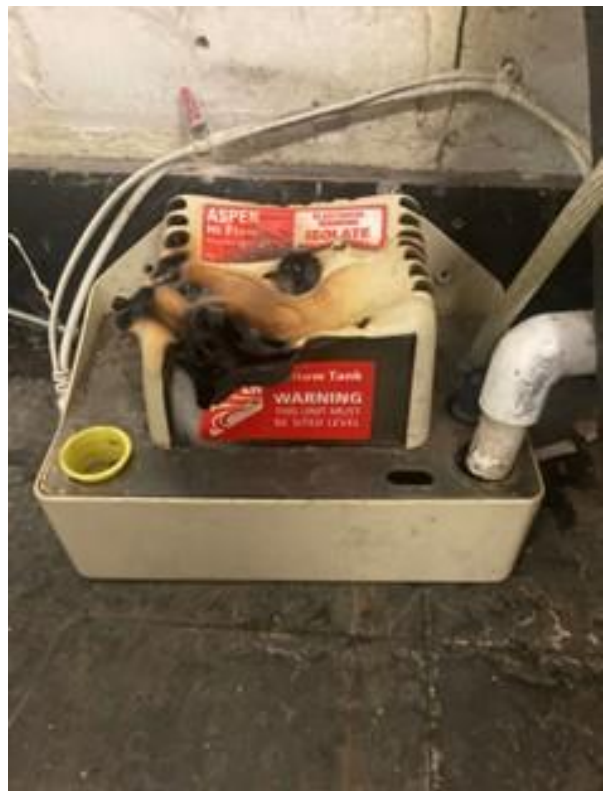
The Fire Service arrived on site at 12:04 and determined that the source of the smoke had self-extinguished prior to their arrival. The origin of the incident was identified as the Aspen Hi-Flow Condensate Pump, as depicted in the attached photograph. No other equipment within the room sustained damage as a result of heat or smoke. Notably, no fire suppression systems or water-based extinguishing methods were required or deployed. As a precautionary measure, the Fire Service isolated the air conditioning unit and disconnected the pump from its power supply.

The precise cause of the pump failure remains under investigation. The unit has been inspected and returned to the manufacturer for detailed analysis. Further updates will be provided as additional information becomes available. The pump underwent its most recent scheduled maintenance in May 2025, at which time it was assessed to be in satisfactory working condition.

- Are the scheduled maintenance activities for air-conditioning units and condensate pumps being undertaken to the correct frequency?
- Do high demand or older systems require more regular maintenance activities?
- Do maintenance activities include regular cleaning to the filters and drain lines to prevent clogs?
- Are the units installed according to the manufacturer's instructions?
