Near miss at Thorney Marsh Lane level crossing, Castle Cary, Somerset, 26 November 2016

2. Summary of the incident

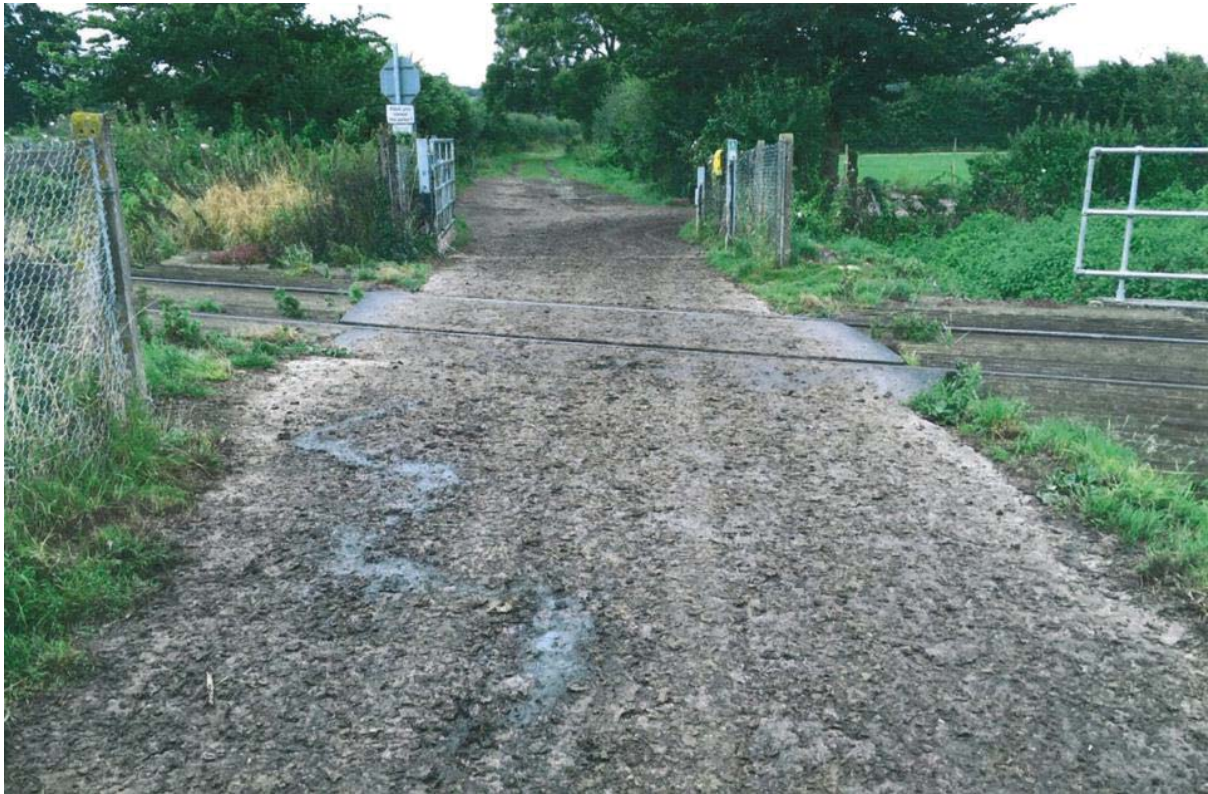
Thorney Marsh Lane level crossing (photo courtesy of Network Rail)

At 07:22 hrs on Saturday 26 November, a train almost collided with a tractor and trailer crossing the line at Thorney Marsh Lane user worked crossing (UWC). The tractor driver had been given permission to cross by the signaller. As he was crossing the line, the tractor driver saw the train approaching and accelerated his vehicle so as to clear the line before the train arrived. The forward facing CCTV pictures from the train show that the tractor and trailer cleared the line when the train was around 30 metres from the crossing. The train was travelling at 73 mph (117 km/h) at the time.

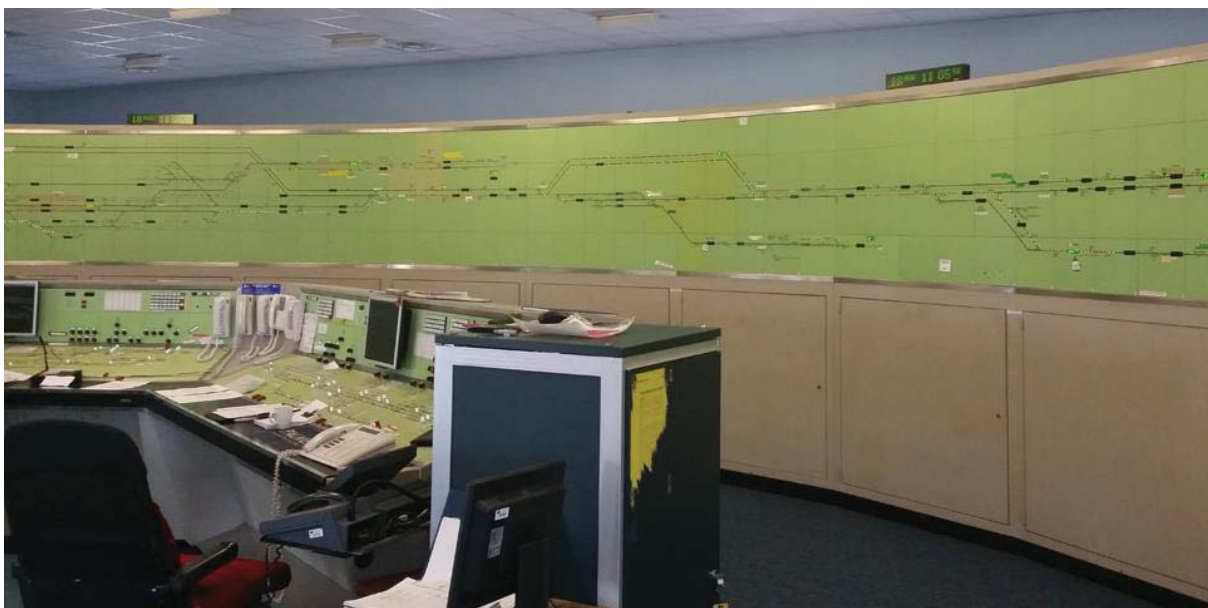
General view of Westbury signal box

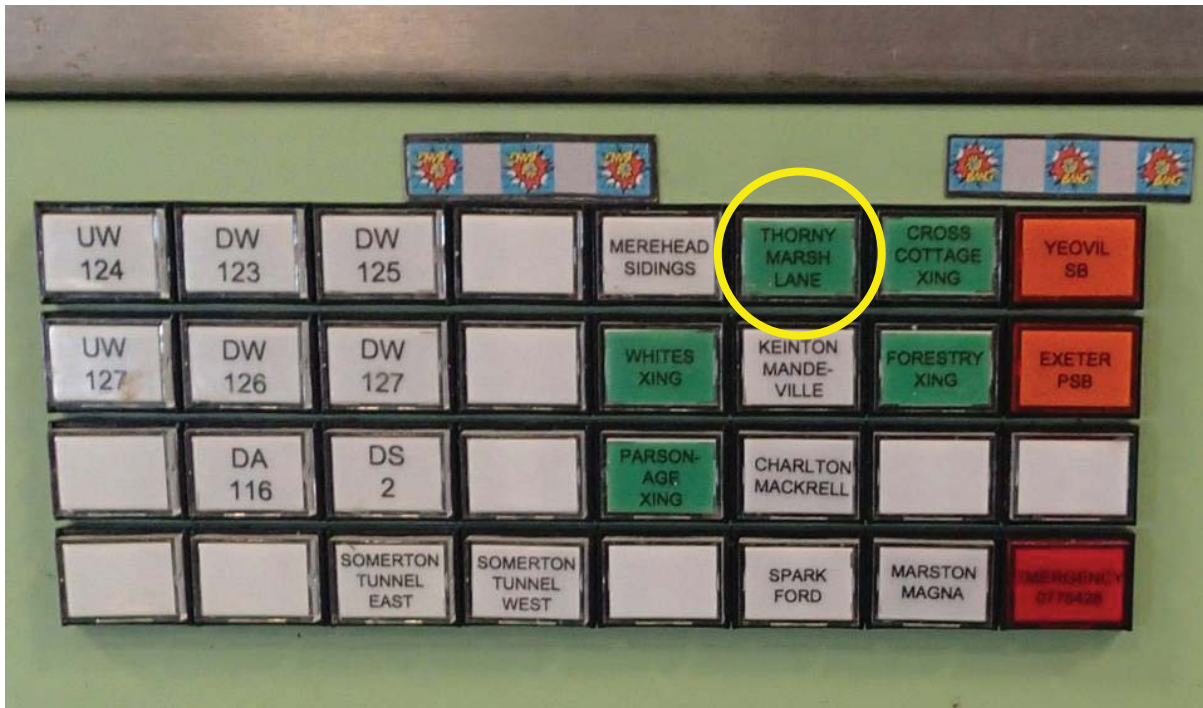
The crossing is equipped with a telephone and signs which instruct crossing users to call the signaller for permission to cross if they are crossing with vehicles or animals. The crossing telephone is connected to Westbury signal box where it is displayed along with other crossings in the area on a telephone concentrator panel.

Telephone concentrator on signaller's control panel. Button for Thorney Marsh Lane crossing circled

During the call the signaller looked at the display panel which showed that the Westbury to Weymouth train was occupying the section of track which starts approximately 2.4 km before the crossing and extends to a point approximately 12.8 km beyond the crossing. The display does not show the location of the train within this 15.2 km long section of track. For this reason, in order to give a user permission to cross when a train is in this section, the signaller must ask them if they have already seen the train pass the crossing.
