# Badgers

Learning from Events Week

1 – 7 June 2020

# Blantyre Railway Station 26 July 2018

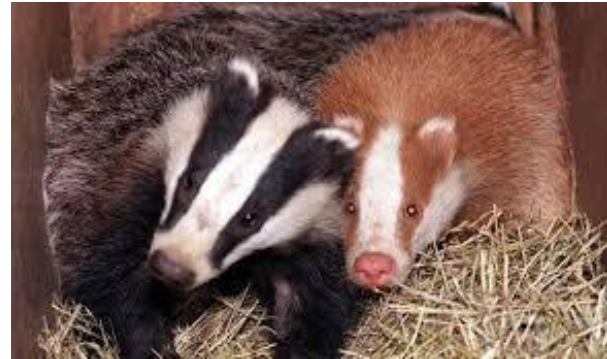
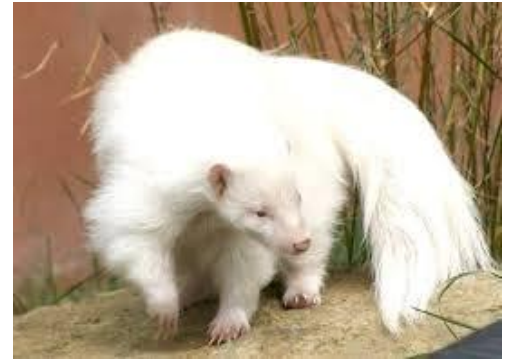
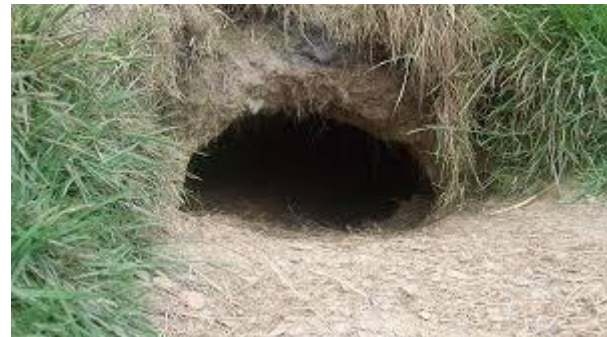
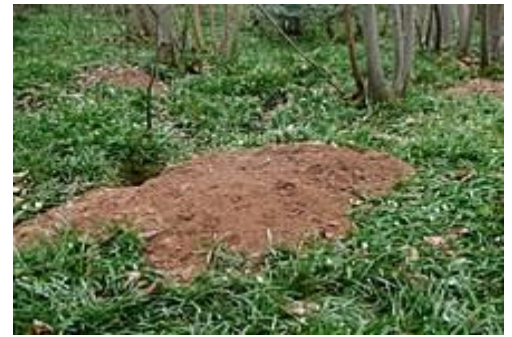
## Identification

- Most badgers have the characteristic black and white striped face although very occasionally they can be creamy white (albino) or red/ginger in colour
- Fully grown adults can be up to 1m in length and weigh up to 14kg
- The sett entrance is usually D-shaped and is around 300 mm wide by 200 mm high. It is wider than either a fox or rabbit hole
- There may be signs of freshly excavated material at the entrance or piles of leaves, dry grass, straw or bracken

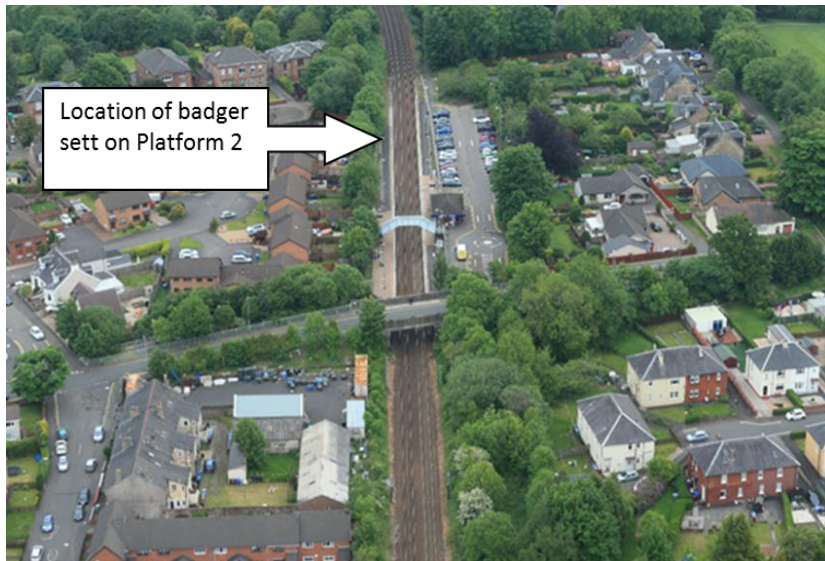
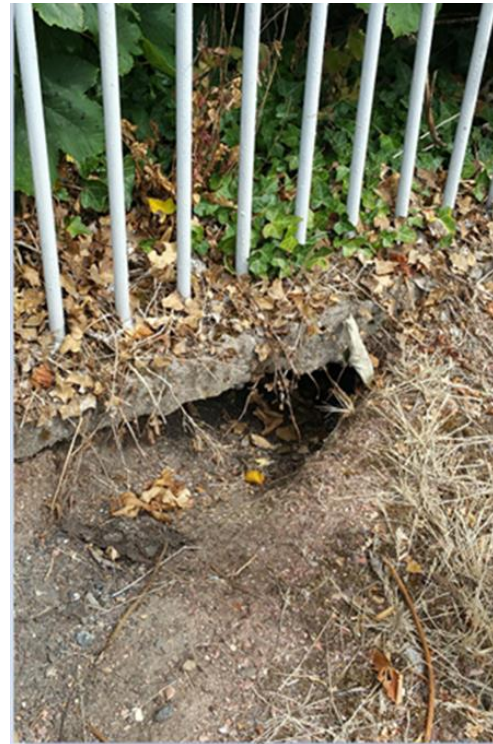
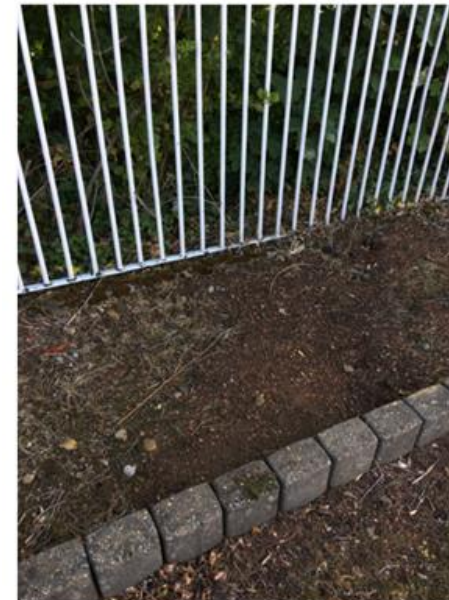
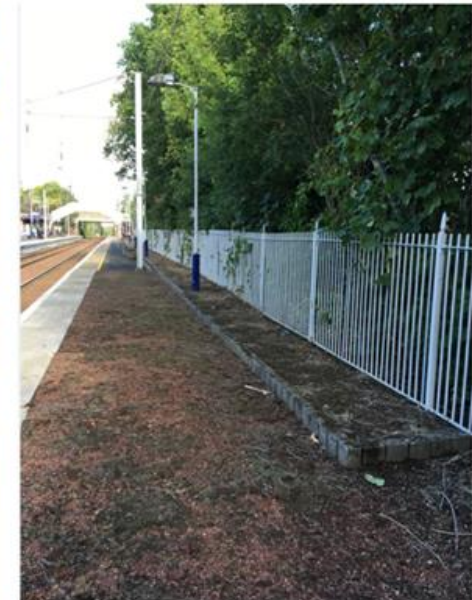
- On Thursday 26 July 2018, 2 Artisans from Network Rail Building and Civils (Route Business Scotland) responded to a reactive fault for a “hole in the grass area “ next to a fence at the Platform of Blantyre Station
- This reported hole was actually a badger’s sett entrance.
- Once at the station the Artisans filled the badger’s sett entrance with concrete rubble and levelled of the entrance at the Platform
- The incident was witnessed by a member of Scottish Badgers

- A site inspection of the badger's sett entrance was completed by Network Rail, Abellio ScotRail and Scottish Badgers and it was established that no harm or injury had come to the badgers

- The investigation team liaised with Scottish Badgers to ensure they knew Network Rail was treating the incident seriously
- All staff who are either based at the station or are responsible for, or carry out work there, were made aware of the sett and the restrictions on dealing with it.

- National Hazard Directory records are now issued with all Network Rail Property Maintenance Work Instruction and Record Forms, within Building and Civils Route Business Scotland.

- Network Rail Building and Civils have mandated in their Property Maintenance – Work Instruction Record form that completion photos and robust self-assurance checks are included for all works

- The Hazard Directory has been updated to have a specific record for badgers on the platform and adjacent area.
- Network Rail met with Scottish Badgers at Blantyre to look at the setts in the area to explore mitigation options for the platform works and to keep Scottish Badgers up to date with any ongoing planned work.

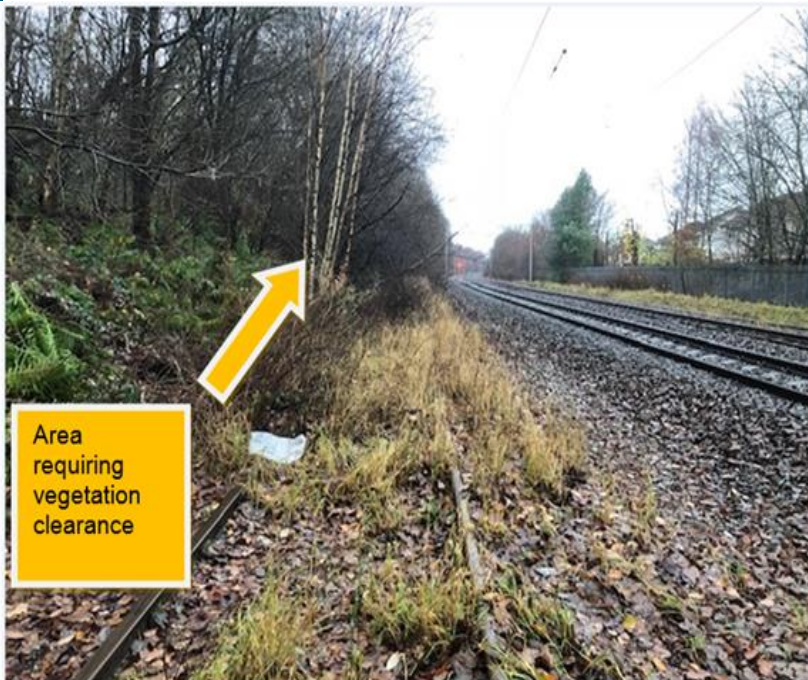
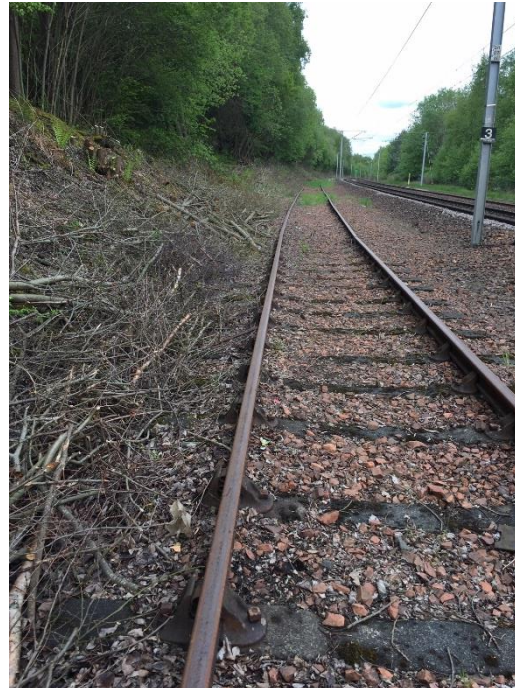
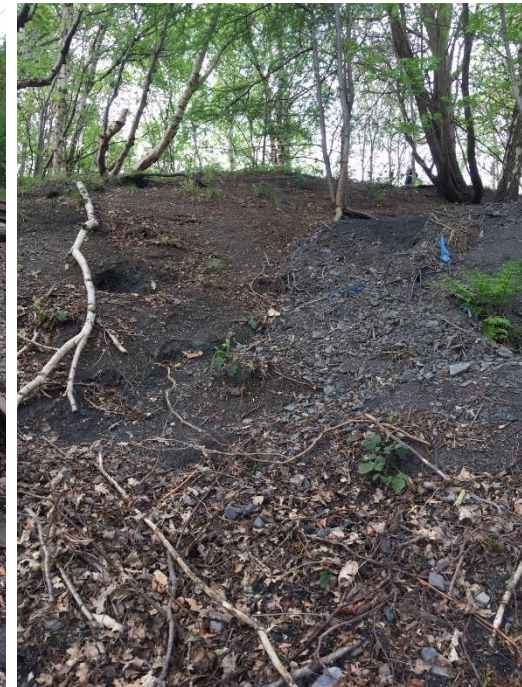
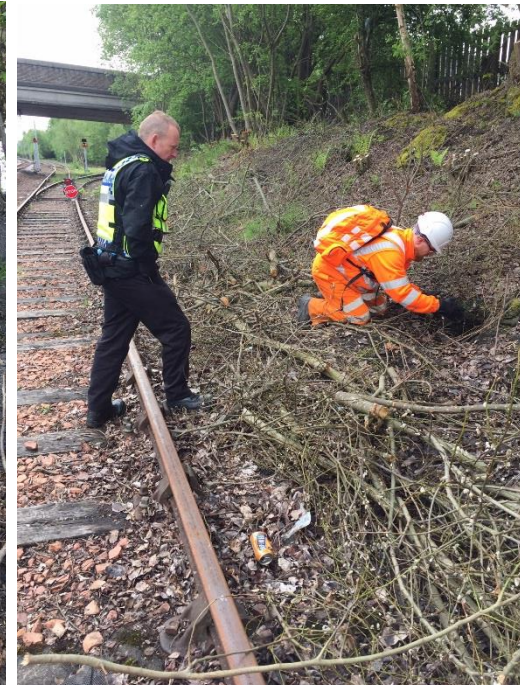
- Operatives from McCulloch Rail cleared vegetation in the siding on behalf of Vita Rail, in preparation for the Royal Scotsman carriages to be accommodated and maintained by Assenta Rail Limited, in E.G Steels yard
- After completion of the vegetation works Scottish Badgers viewed CCTV they had installed at Earnock Sidings, this monitored badger activity and found that parts of woodland which housed the badger's setts had work completed around it. Scottish Badgers alerted the British Transport Police (BTP).
- BTP carried out an investigation but no prosecution was sought as it was not possible to determine if the badger's sett was damaged or the badgers had come to any harm or injury. This was due to the large size of the sett, which had multiple entries/exits

- A site inspection was completed by Network Rail and BTP to establish if harm or injury had come to the badgers. The results of this were inconclusive due to the badger's sett being very large.

- Network Rail completed a Level 1 investigation into the incident to identify the immediate cause, underlying cause
- Network Rail, IMDM Motherwell implement changes in the Hazard Directory to reflect the location of the badger's sett at Earnock Sidings.

- Network Rail ASPRO team implemented steps for positive proof of land ownership from the Sponsor or Client department (Freight) before any works begin.
