COSTAIN
The Thameslink Programme

Issue Number: TLP068
Title: Person Lifted by Tag Line

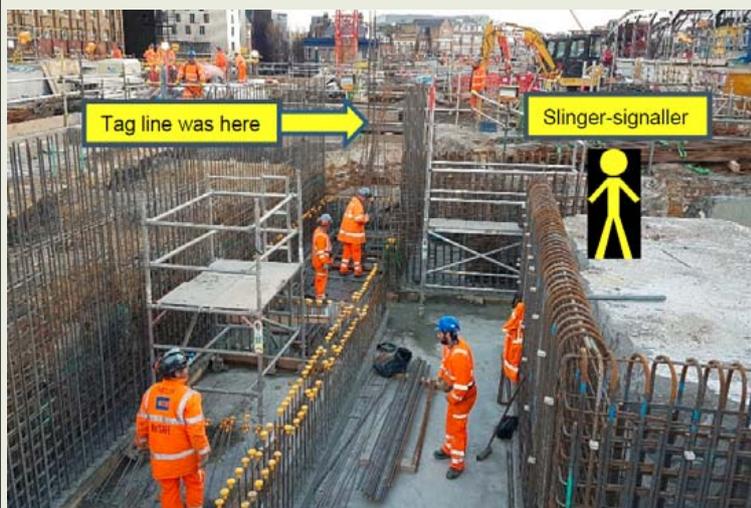
Photo of Event :

An operative (steelfixer) became entangled in a tag line during a lifting operation on our Construction Site at London Bridge during nightshift works. The load had been unslung and the crane was hoisting up when the tag line got caught around the steelfixer's ankle. He was lifted approximately 2.5m high before the team became aware of the situation. He managed to grab the tag line as he was lighted to remained upright. He was lowered back down and received no injuries.

Immediate Cause – The tag line became wrapped around the steelfixer's ankle.

- Procedure – the steelfixer was not trained in carrying out slinger-signaller tasks. The load had not been landed correctly due to number and placement of timber bites resulting in chains becoming trapped.
- Training / Communication – the slinger-signaller was routinely turning away from the chains once the load was removed. This had been observed by the crane driver but not reported.
- Supervision – the steelfixer supervisor permitted the steelfixer to remove the chains.
- Housekeeping – there was a significant amount of rebar in one area. Crane was operating at its maximum radius resulting in rebar being landed partly on top of another which contributed to chains being snagged.

- All persons on site briefed that lifting of loads is a specialist activity (Costain are developing a specific briefing to educate people involved with helping out slinger-signallers)
- All crane supervisor and slinger-signallers had a competence assessment undertaken by their respective employers/ supervisor
- Formal lift team meeting to be established with rotating attendance by personnel
- Increased surveillance by Crane Supervisors and other "grey hat" supervision
- Review behaviour/culture of persons including general supervision and enforcement of rules
- Review planning of works and review of logistics, in particular just in time delivery. Only delivered what can be fixed in the same shift.
- Lifting Compliance Check Sheet to be used; this embedment/key learning from this incident is prompted on the form.
