No: IGS 191

Infrastructure Group Safety Bulletin

Worting Junction – 2nd April 2009: Trackman suffered burns.

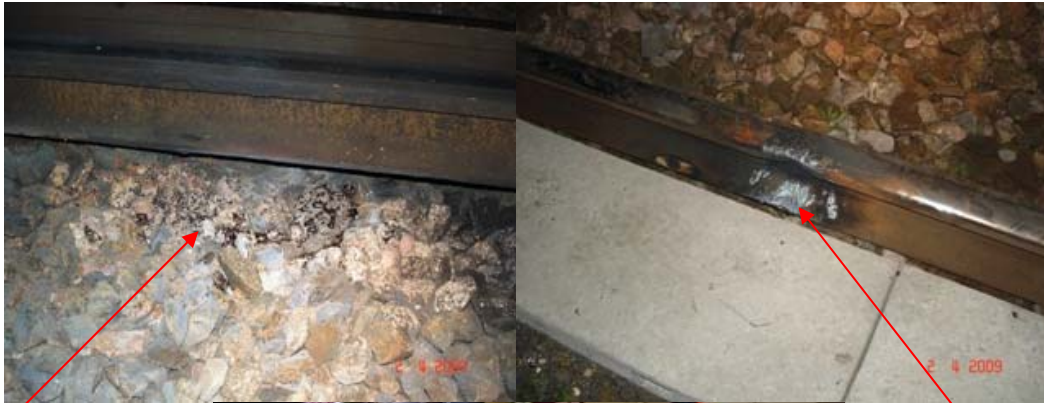
Damage to the SCS clamp and resulting metal debris on the ballast under the conductor rail

All staff carrying out the application of Short Circuit Straps must be competent in the activity and strictly follow the training and correct procedure for this task as outlined below.

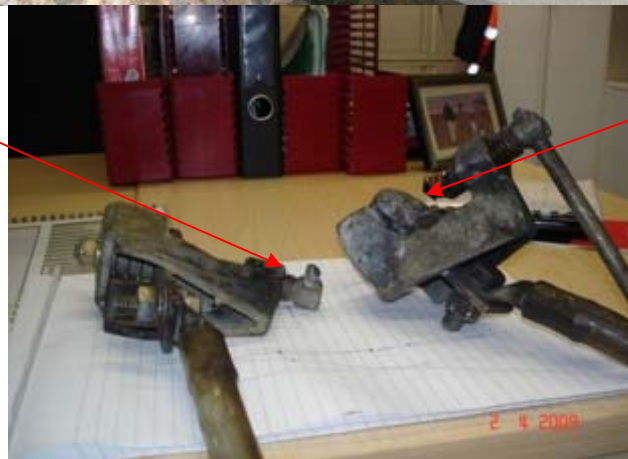
Significant burn damage to the SCS clamp and corresponding damage to the running rail.

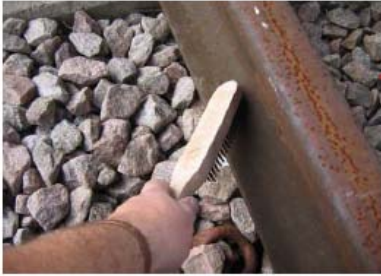
1. Clean the running rails with a wire brush at the position where it is intended to fit SCS. The top & underside inside foot of relevant running rails only, need to be cleaned.

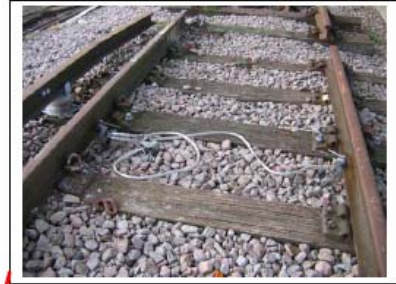
2. Prove test lamps on known live source. Apply test lamp set to relevant conductor rail to prove the conductor rail to be strapped is "Dead". Leave in position.

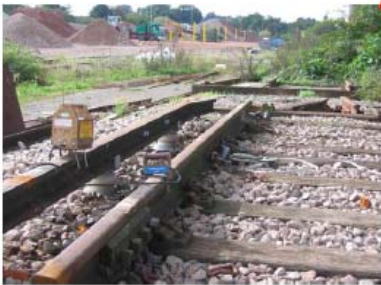
3. Attach clamps of SCS to running rails. Clamps will be secured as tightly as possible - this is critical to ensure that straps remain in position to protect workforce. Leave 3rd clamp in 4 ft. Note: If clamps are not fitted securely this may cause them to fall off during re-energisation.

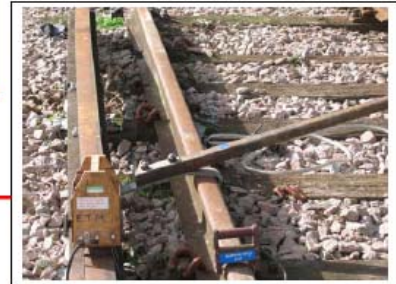
4. When conductor rail has been proved "DEAD" apply short circuit bar to the conductor rail. Leave in position while connecting SCS

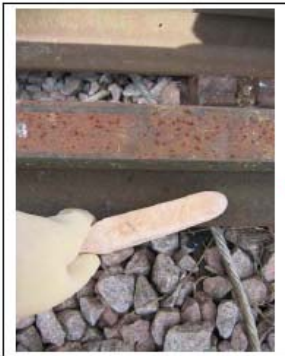
5. Wear insulated rubber gauntlets to clean with the wire brush the position on conductor rail where SCS clamp is to be fitted, the top and underside of foot. (Side furthest from relevant running rails)

6. Apply remaining SCS clamp to conductor rail. Pass the clamp under the running rail and conductor rail. Secure clamp as tightly as possible to outer edge of conductor rail foot. This is critical to ensure that straps remain in position to protect workforce.

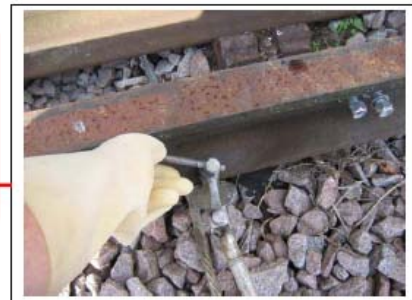
7. Remove short circuit bar and test lamp set.
