No: IGS 260

Infrastructure Group Safety Bulletin

Bridge Demolition

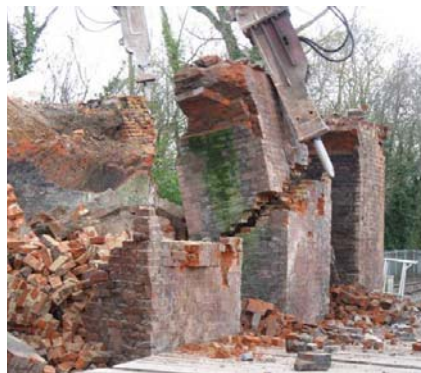
On 8th April 2012, a side arch belonging to a 3 span bridge at Beenham Lockside, collapsed following the demolition of the centre span.

The matter is subject to Formal Investigation however initial accounts suggest that the propping forces of the centre span may not have been considered during the planning process. As a consequence, it seems that the demolition was carried out without adequate temporary support in place in order to prevent the side thrust from the unrestrained arch pushing over the pier, leading to the subsequent collapse of the structure.

Collapsed arch at Beenham Lockside

- The stability of the whole structure is assessed for all stages of the demolition and the use of temporary supports considered at all times. The temporary supports must be specifically designed by competent engineers.
- In the specific case of multi span bridge arches, adjacent arches and piers are to be stabilised by temporary works specifically designed to provide the restraint necessary to prevent an uncontrolled collapse, whilst the works are carried out.
