No: IGS 224

Infrastructure Group Safety Bulletin

Door Pins on BASS Wagons

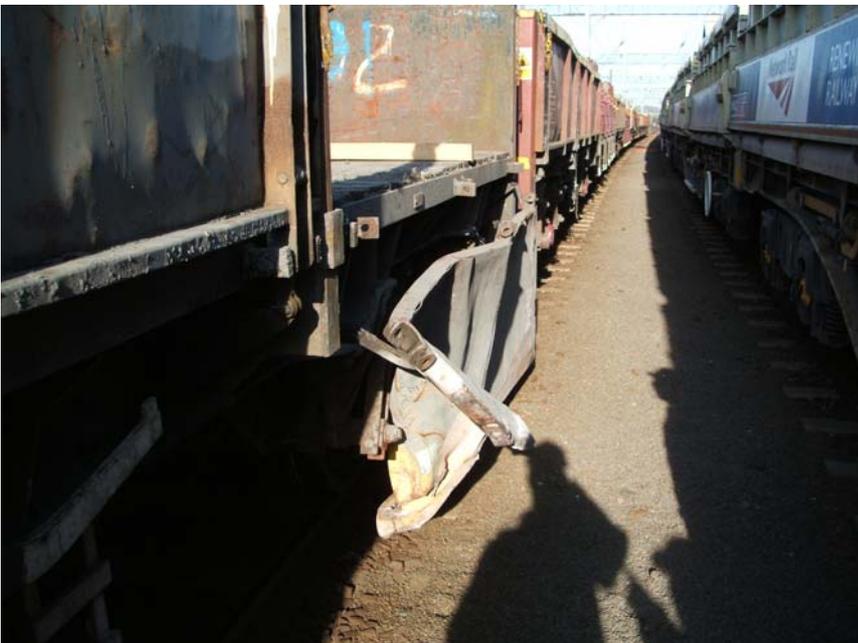
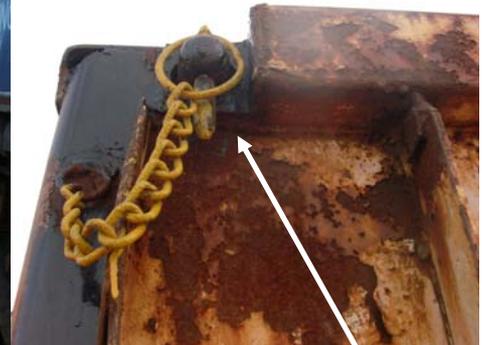
**All pins must be
in this position
before the
vehicle enters
service**

Following the earlier incidents, the pin heads and chains were painted yellow and the background black to help identify pins that were not fitted.

All pins must be in the correct position (see below) before the vehicle enters service.
