No: IGS 232

Infrastructure Group Safety Bulletin

Cable Protection from Rail Delivery

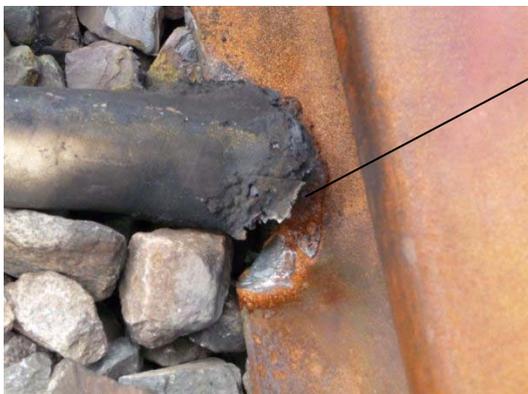
Damaged
Rail

A recent incident occurred whereby electrical cabling was damaged following a delivery of rail. The rail was laid using supporting saddles to protect the cabling, in this instance the saddles were not raised enough to keep the rail completely off the cable. In another area rail was directly laid onto cabling without any cable protection; the heating and cooling effects of the recent weather conditions caused the delivered rail to expand and contract and consequently cut through the insulation of the traction return and other cables. The rail foot was damaged by arcing rendering this piece of rail unusable.

- During the rail delivery site walk out all relevant cabling and other track furniture requiring protection are to be identified and recorded on the Lineside Equipment Protection Form by the rail recipient and the Network Rail Delivery Contractor.
- Agreed and appropriate protection is to be actioned prior to the planned rail delivery by the recipient of the rail.

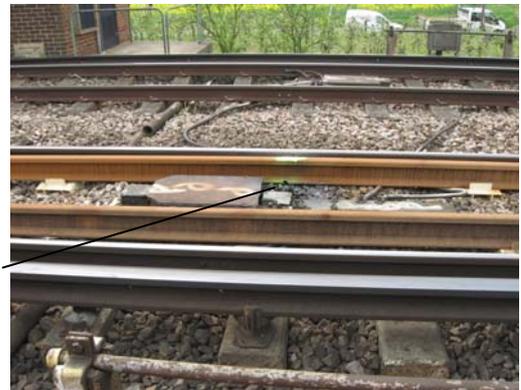
Impedance
Bond
