No: IGS 239

Infrastructure Group Safety Bulletin

Quality of Vortok Conductor Rail Shields.

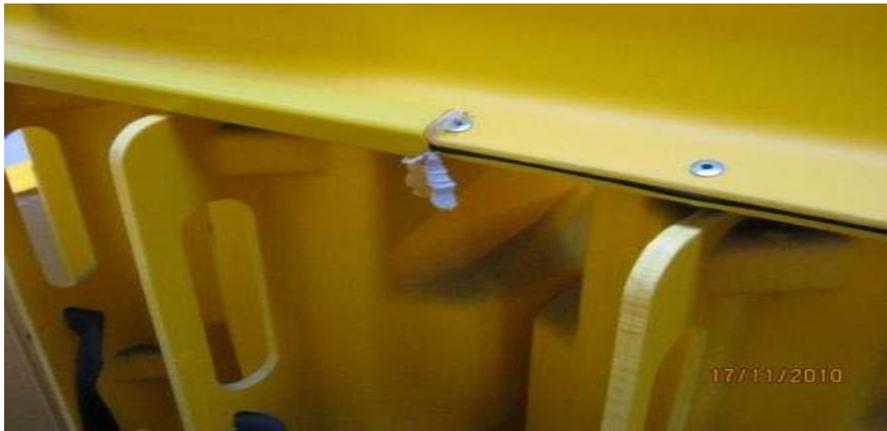
It has become apparent that some of the new yellow Vortok Conductor Rail Shields have become damaged in the following ways;

- Cover strip material has come away exposing metal rivets
- Damage to the flaps covering the bottom of the shield.

1. **Line Managers** to arrange a check of all shields of this type
2. **All Staff** are reminded to carry out the pre use inspection prior to use of these shields to check that they are undamaged.
3. **Specific care should be taken to examine the flaps and to check they and the cover strip are securely fastened and that none of the metal rivets are exposed**
4. **In the event of a Vortok Conductor Rail Shield being found to be damaged it must be quarantined and a replacement used**
