No: IGS 249

## Infrastructure Group Safety Bulletin

### Use of Ballast Plough Attachments

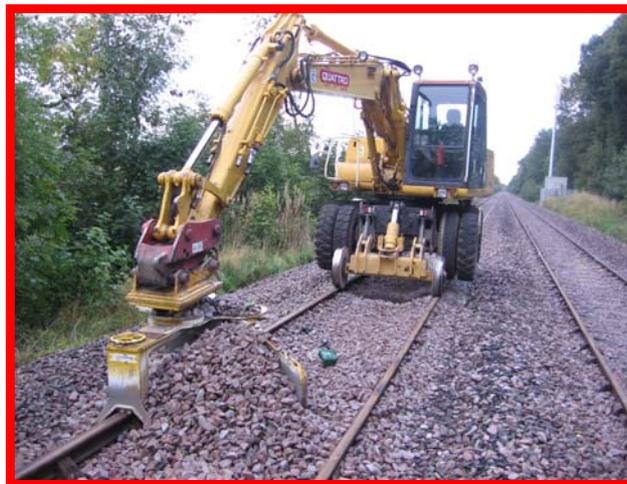
In September 2010 a serious incident occurred during the use of a ballast plough attached to a Road Rail Vehicle (RRV). As a result the Machine Controller (MC) suffered serious leg injuries after coming into contact with the RRV. Factors leading up to this incident included;

- A failure to establish a SSO including communication, and
- The proximity of the MC and the equipment during the ballast ploughing.

- ✓ To check that the RRV and ballast plough are suitable for the amount of ballast to be regulated and that the work plan identifies this clearly.

- ✓ Carry out the pre-use inspection of all equipment and review the work plan.
- ✓ Implement a safe system of work including a means of communication between the Operator and MC prior to commencing ploughing tasks.
- ✓ Maintain an appropriate exclusion zone around the machine including the attachment whilst working.
- ✓ Not distract the operator while ploughing is in progress.
- ✓ Constantly review and assess the worksite conditions.
- ✓ When ploughing no movements shall be at speeds greater than walking pace
