No: IGS 183

## Infrastructure Group Safety Bulletin

### Door Securing Pins on Infrastructure Wagons

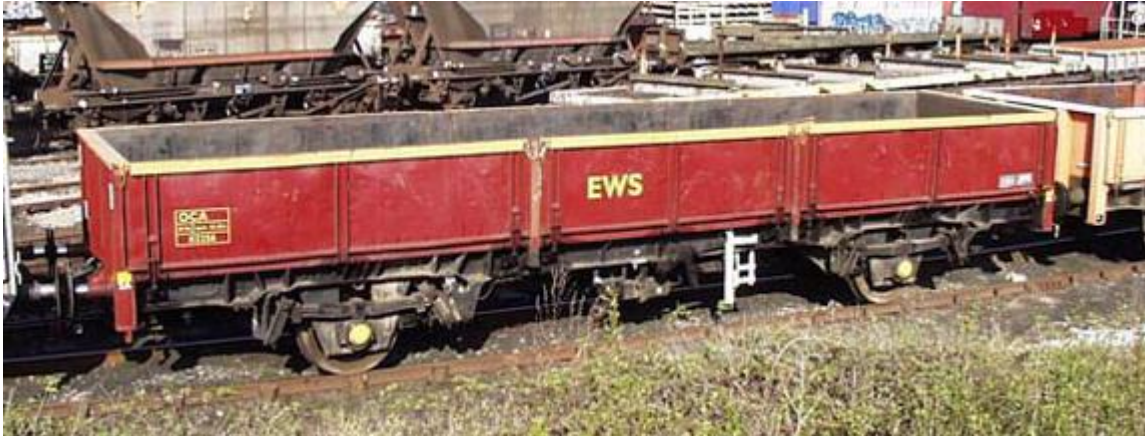
A serious incident was reported at Twyford recently where the side door of an OCA wagon came into contact with a passenger train after leaving the worksite.

The exact circumstances are being investigated but staff are reminded to check that, when securing wagon side doors they are secured at each end by the correct pins before any movement takes place.

- Wagons that do not have the correct pins fitted must not be allowed to enter traffic.
- Wagons that have the correct pins but are not fastened to a securing chain must be Carded for Repair.

**All wagons found with incorrect securing pins or pins not connected to a securing chain must also be advised to the Network Engineering Section:-**
