No: NRS 267

Network Rail Safety Bulletin

Action to be taken regarding handrails on bridges

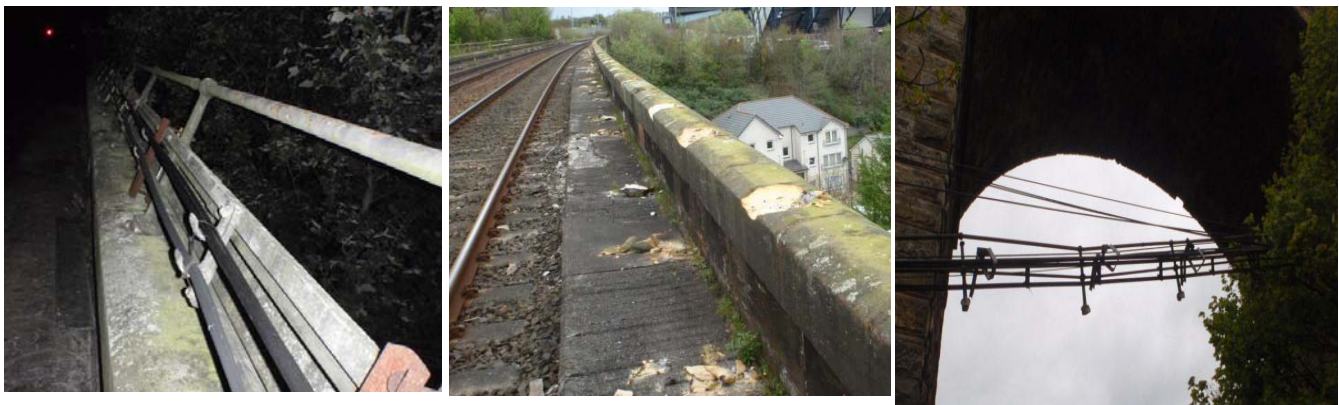
Last year, the handrailing on the Inveriel Viaduct on Scotland Route was seen to be misaligned and in a potentially insecure condition(photo on left). The handrailing also carried several cables. Remedial work was not carried out.

In May 2012 the handrail pulled out of the parapet and fell almost to ground level (photos above: centre and right): cable troughing fell to the road below and the parapet edge became inadequately protected to trackside personnel.

If you are concerned about the condition of a handrail on a bridge:

- Don't ignore it: it is your duty under the Health and Safety at Work Act 1974 to report it!
- Report it to the relevant Control Centre, stating location, structure number and reason for your concern

If you are planning to make a change to a handrail (eg: attach cables or other kit):

- Obtain approval before making permanent alterations, or adding significant temporary additional load (eg cables) to a handrail, by contacting the Route Asset Manager (RAM) (Civils)
- RAM (Civils) will decide whether the handrail is able to safely accept the changed load and give further guidance as necessary
- Network Rail Standard NR/L2/INI/02009 requires that new work is to be correctly integrated with existing infrastructure, for which the RAM (Civils) will need to be consulted
