No: NRS_306

Network Rail Safety Bulletin

Top Head Hammer incident

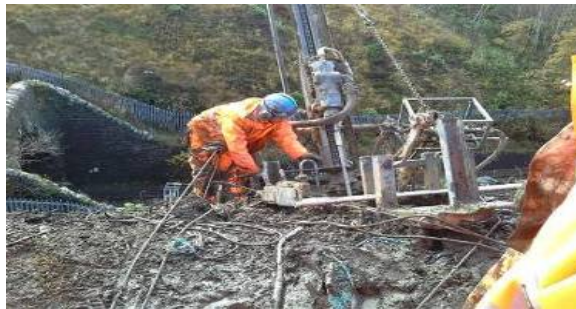
An incident occurred recently when an assistants hand became trapped between the releasing tool and the main framework of a **Top Head Hammer Rig** during the extension/fitment process of a nail/rod extension.

It has been reported that there was a communication breakdown between the operator and the assistant whilst a nail/rod extension was being fitted. This resulted in the rig being operated whilst the assistants hand was inside the equipment.

Action Required: **All drilling rigs are suspended from use** on Network Rail managed infrastructure until it can be shown that;

- Rigs are **CE marked** (or equivalent), this is the manufacturer's declaration that the product meets and is compliant to UK legislation.
- Rigs have **operational manuals** available for instruction and training purposes
- Rigs have a **training manual / program** for that specific item of equipment and operators have been **trained and have training records** available.
- Rigs have **maintenance and inspection records** with the next due date for statutory inspection displayed on the equipment.

Operators are also reminded to comply with the relevant task risk control sheet, risk assessments and complete pre-use inspections.
