No: NRS 320

Network Rail Safety Bulletin

Trojan Trotred

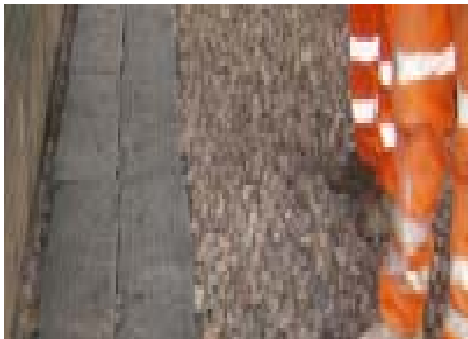
Picture of TroTred with lids fitted correctly

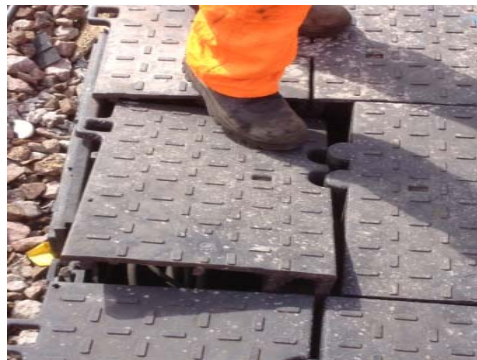
There have been two incidents of falling, by railway personnel, whilst walking on Trotred. The product has been approved for slip resistance, but there have been incidents where, following removal of the lids to install cables, the side walls of the Trotred have been deflected inwards due to weight from adjacent ballast and preventing the lids from being replaced correctly. This causes the outer edges of the Trotred lids to be unsupported and move unexpectedly under the weight of footfall thus creating a trip hazard.

Picture of TroTred with displaced lid

Please ensure all Trojan Trotred lids are securely attached to the side walls and are not displaced from their correct positions.

Trojan are working to create a solution to the displacement of the TroTred lid. This involves;

- 1) redesigned lid to include lugs for the centre and increased antislip.
- 2) Further investigation and modelling by Trojan into the joint at the bottom of the trough to provide greater stability and resistance to side wall forces.
