No: NRS 327

Network Rail Safety Bulletin

Fall from height from HGV

For the attention of Network Rail Staff and Contractors delivering and receiving loads from HGVs

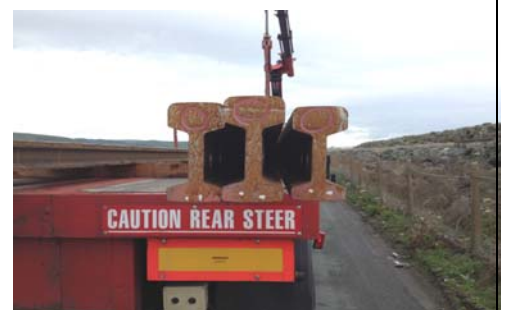
The HGV was loaded with each rail touching the next. To enable cam locks to be placed around the rail head for unloading, the operator had to access the trailer via ladder and bar the rails apart manually.

While moving the rail, the bar slipped and the operator fell off the trailer onto the ground.

- Always have a suitable risk assessment in place before commencing any activity
- Always use equipment for working at heights that is fit for purpose
- Unless it is clear other protection is in place, never work at height without a safety harness
