# Safety Bulletin

## Fatal accident involving a young person

**Ref:** NRB 15/12

**Location:** Wrenthorpe Sidings

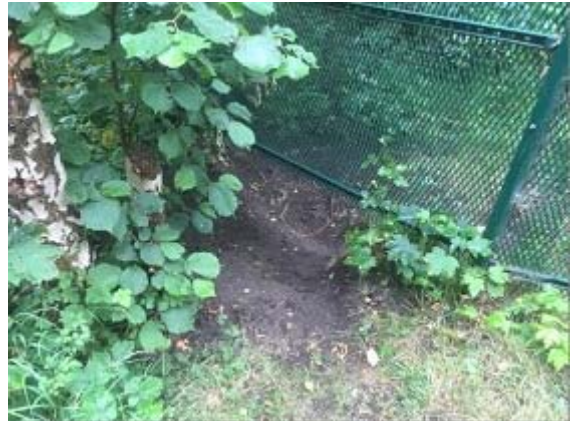
Route dug under fencing

The facts remain subject to determination by the coroner however initial reports suggest that the teenagers gained access to the railway by climbing over the parapet of a railway underbridge and then under two fences.

There was a well-trodden path for the route the teenagers appeared to have taken with a route under the fences having been dug out.

- How can we best prevent access to railway sites like this?
- Can we improve the checks on our fence lines to make sure they are secure?
- When we receive reports of trespass what do we do to understand the risks at the location?
- How do we assess whether sidings used for wagon stabling really need electrification assets to be live?
- What would you do if you saw a trespasser on the railway?
- How could you help communicate to local communities the dangers of the railway?
