No: NRS 335

Network Rail Safety Bulletin

Accident involving a lorry mounted crane fitted with a brick-grab attachment

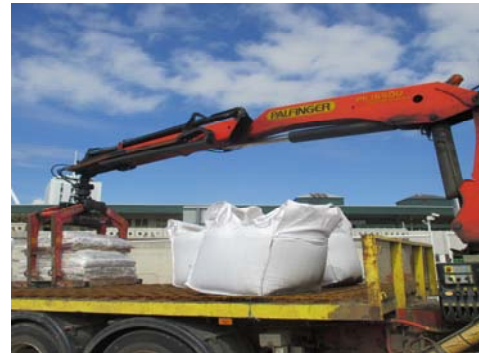
On 2 September 2014 a serious accident occurred at Cardiff Central Station during the delivery of bulk materials in 1 tonne bags. The bags were delivered and off-loaded using a lorry mounted crane with a brick grab attachment fitted with hooks for delivering bagged materials.

During the operation an employee of one of our contractors acting as the slinger was caught between the arms of the brick grab and suffered serious injuries.

- Do you always follow the lifesaving rule “Never enter the agreed exclusion zone, unless directed to by the person in charge”?
- Are you aware that lorry mounted cranes **MUST** be isolated where loads need to be attached / detached manually? Where a remote control device is used this **MUST** be isolated at all times when it is not in use, when attaching and detaching loads or when anyone, including the operator, is working in the vicinity of any loading attachments.
- Do you always ensure that for this type of operation the operator and any other staff working in the delivery / collection area set up an exclusion zone?
- Do you always agree the communication protocol between all parties that indicates that the loading equipment is isolated and it is safe to approach the load and any loading attachments?
- Do you need to change the way you work to keep yourself and others safe?
