No: IGS 319

Network Rail Safety Bulletin

Electric Shock to an Employee at Hamilton Square Station, Merseyrail, Liverpool

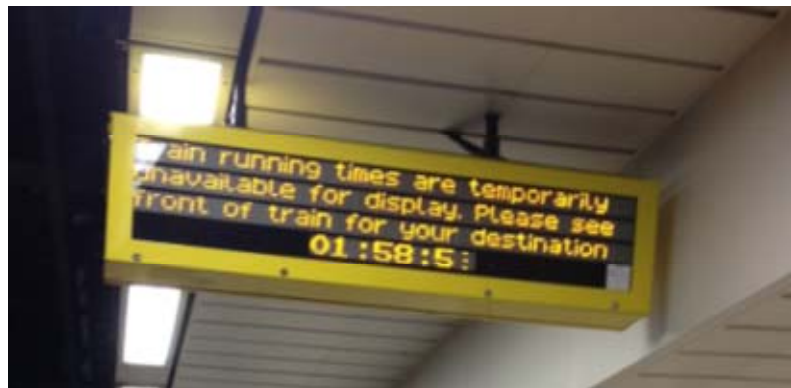
Background: On the 27th February 2014 at Hamilton Square Station, Merseyrail, Liverpool, an employee of Network Rail received an electric shock whilst working on a telecom customer information system fitting (CIS), as per the photograph below.

The injured person had isolated what should have been the mains input cable (the live leg of the mains input) by removing a fuse, and then tested for live electrics before touching the equipment. However the polarity of the cable from a line filter unit was reversed for electrical flow and the injured person received an electric shock from the equipment (240V AC) due to incorrect wiring during installation. A subsequent examination of the CIS unit revealed it had been wired incorrectly (reverse wired), and several others in the immediate vicinity (Hamilton Station) were found to be in a similar state and corrected.

- Relevant staff to be briefed regarding the Life Saving Rules.
- All relevant staff to ensure mains supplies are isolated, to test all wires for live current and to conduct a test to earth before touching. Relevant staff should not rely on the removal of fuses or testing of the live leg only.
- All relevant staff who fault/inspect CIS units to be made aware of this incident, and the remedial actions and control measures required.
- An investigation has commenced and the findings will be issued in due course
