Lessons Learnt from a Significant Event

Issue Number: TLP001

Title: Bermondsey Dive Under Project, Severe Burns – 21st November 2012

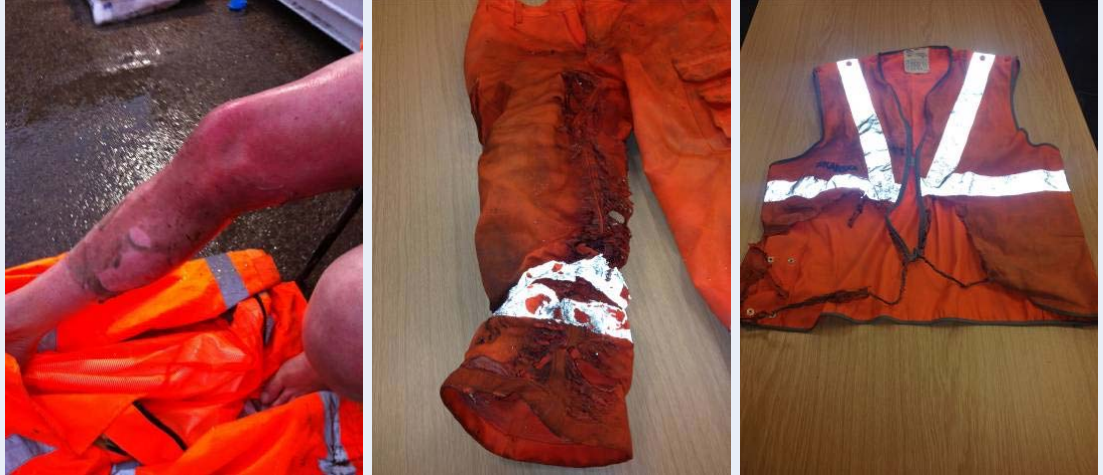
Photographs show the burn injury to the operative's leg as well as the condition of the PPE after the accident

An operative sustained serious burns to his leg and hand which required skin grafts.

As the operative was cutting through one of the bars, he was unaware that he was being doused with fuel that was escaping from the petrol filler cap.

Sparks generated from the cutting, ignited the petrol, which in turn set fire to his hi-visibility trousers and vest.

* The IP was wearing standard issue trousers which are nylon. The Stihl saw manual recommends when cutting steel that flame retardant materials should be worn. The fact that an accelerant was involved may not have prevented the injury however this highlights the need to review user manuals for specific instructions.

- Consideration for alternative methods of cutting such as hydraulic cutting for the removal of vertically protruding reinforcement bars from piles
- Pre-use checks should be undertaken on machinery and tools in order to establish they are fit for purpose
- Plant / equipment suppliers should provide manuals for equipment provided
- Manuals should be used to inform the risk assessment / task briefing
- PPE selected should be appropriate for the task
- No works should be permitted without a task briefing having been undertaken
