Lessons Learnt from a Significant Event

Issue Number: TLP010

Title: London Bridge Station Redevelopment – Ground Failure beneath Piling Mat

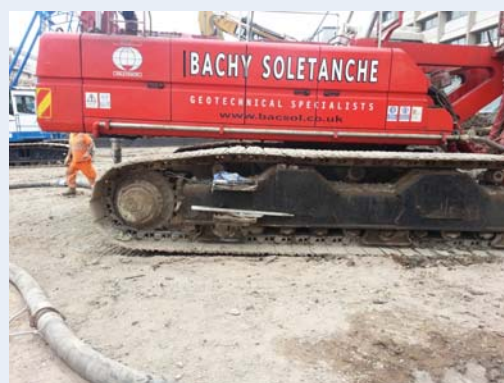
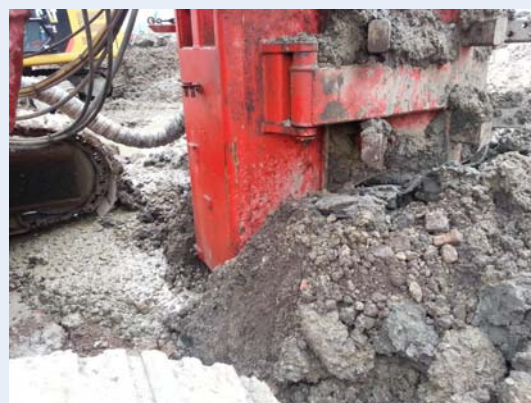
- On 20th July the ground beneath a piling mat failed causing the piling rig to sink into the piling mat.
- The piling rig had drilled down to a depth of approx. 27m and the team had commenced pumping the concrete whilst withdrawing the auger. As the auger reached a depth of approx 22m, the piling mat beneath the piling rig stabilising foot failed.
- The foot of the rig sunk approximately 300-400mm causing the rig mast to lean.

The Photographs below show the tracks of the rig lifting and the foot of the rig sinking into the piling mat

- The vertical load from the piling rig foot was too great for the ground below the piling mat and caused the rig to go out of plumb
- There was no site investigation carried out specific to the design of the piling mat. The soil parameters were taken from soil investigations earlier in the project and from a different part of the site.

- The undrained shear strength of the existing ground below the piling mat was deemed to be 35kPa. Investigation subsequent to the incident using SPT testing has shown this to be inadequate.

- The London Bridge team now stipulate that the Cat 3 checker will independently review design assumptions for their suitability (rather than just confirm the calculations)
- For London Bridge station works the permanent works designer will be consulted on the ground strength assumptions through written correspondence for all temporary works
- Information to inform designs should be valid and specific to the area
- Changes to design should go through the correct temporary works sign off process
- All close calls should be reported and acted upon as near real time as possible to learn and take action quickly
