No: IGS 252

# **Infrastructure Group Safety Bulletin**

## **Accident at Hither Green Depot.**

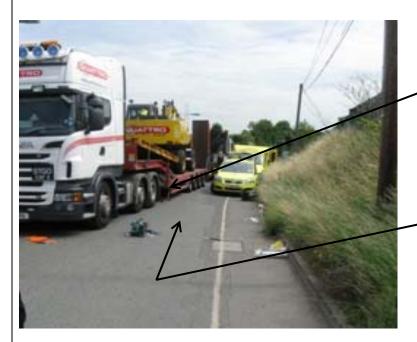
Fig 1:- Site of the Accident

The injured person was working at this point.

This is the scene after the injured person has been removed to Hospital. This is also the view the driver would have had as he left the depot approaching the stationary low loader.

From marks at the scene, it is believed the front offside wheel mounted the kerb, onto a grass verge.

It is believed the rear wheel failed to follow the front and was constrained by the kerb. It is believed the rear of the moving lorry crushed the injured person against his lorry.

Action Required: All employees
<ol> <li>All employees and contractors are to be briefed on the circumstances of this accident and reminded of the risks in and around depots and access roads from moving vehicles.</li> </ol>
<ol><li>All employees must consider and implement a safe system of work when working on the off side of a vehicle on the public highway.</li></ol>
<ol><li>When using Road Rail Vehicles, all employees must consider the arrangements in place for delivery/collection of the Road Rail Vehicle.</li></ol>
This Safety Alert must be displayed for 28 days on the Safety Notice Board
Issued by: Justin Page, Head of Infrastructure Maintenance Safety and Compliance
