Lessons Learnt: Local & Formal Investigations

Issue Number: Southern 001

Title: Gatwick 750v DC ETE cable flashover event 3rd December 2013

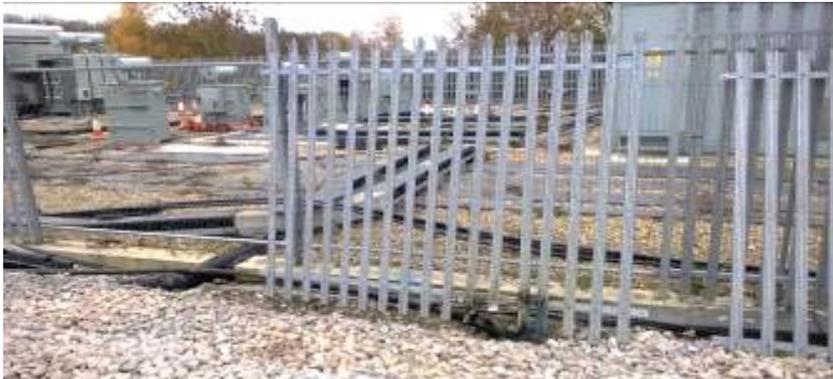
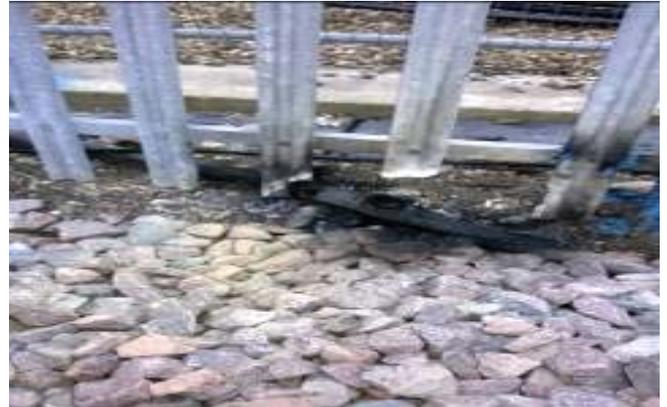
In order to provide access to a sub-station 2 sections of Palisade fencing were removed and leant against the remaining compound fencing. The fence panels were not secured in any way to prevent them from falling or being moved.

At some point over the following weeks one section of fence was moved again; only this time it was left resting on a 750v DC ETE cable.

Later in the programme operatives running signal tail cables saw a flash and the above damage was discovered – one of the fence panels had pierced the insulation of the 750v DC ETE cable, resulting in arcing and burning and damage to the panel.

Before storing equipment in the vicinity of surface cables ensure that they do not sit on top of the cables

Protect existing cables with inverted trough, supported timber sheets or use cable/hose protection ramps.

Always ensure that when storing fencing panels that they are secured and not stored on top of Power cables
