Lessons Learnt: Local & Formal Investigations

Issue Number: 002

Title: IP Southern: Fall from Scaffolding

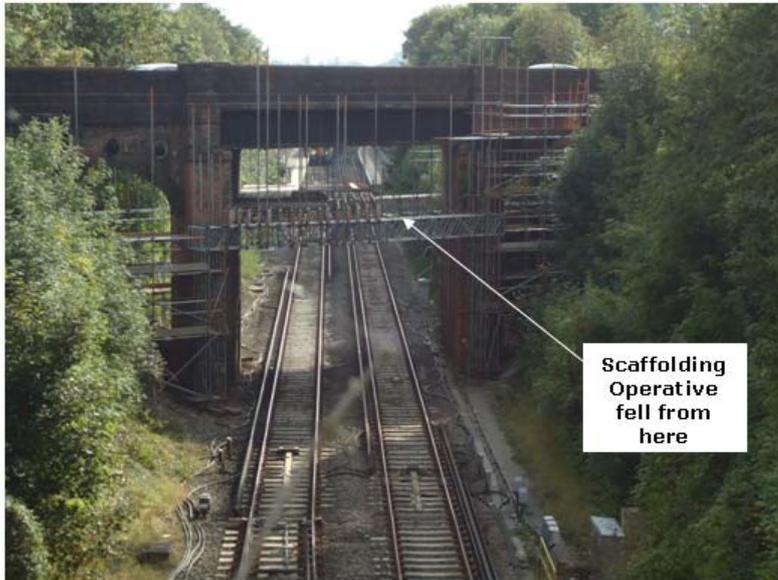
At some point the operative went for a drink of water; appears to have “blacked out” and fallen 5.5 metres on to the track below.

The operative fell from the scaffold because he was not restrained by his lanyard and safety harness because the lanyard and safety harness were not connected to the scaffolding at the time.

**Always use a safety harness when working at height, unless other protection is in place.
This includes access and egress from scaffolds**
