EVENT LEARNING

013

Works Taking Place / Incident Type: *Unloading from wonder wagon / Specified RIDDOR injury*

Project Name / Number: *Kirknewton & Midcalder / 129624*

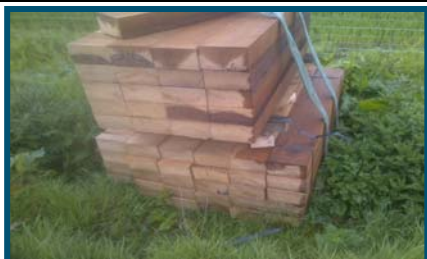
During possession working, the planned work activities were changed due to interface arrangements with other works and weather conditions. Subsequently, when unloading ballast retention boards from an RRV wonder wagon, appropriate tools for releasing banding straps were not used and no provision was made for working at height. The injured person (IP) climbed onto the RRV wonder wagon to help remove the load and it moved without warning. The IP tried to move away and fell on to the ballast shoulder fracturing his wrist.

- The planned safe method for unloading the ballast retention boards was not followed.
- Change and related time pressure affected how the activity was undertaken.
- Risks associated with the changed method were not adequately assessed.

Unless it is clear other protection is in place, never work at height without a safety harness.

- Discuss this event at your next safety meeting or with your supervisor. How do changes to methodology / tasks introduce risk?
- Discuss the arrangements for your particular projects on how loading and unloading from vehicles is undertaken safely. Is working at height identified as a risk?
- During your next safety inspection discuss arrangements for unloading or loading materials from vehicles.
