EVENT LEARNING

No.019

Incident Date / Time: 13th November 2014
Location: Calverley
Works Taking Place / Incident Type: Bridge Works / Accident, Minor Injury
Issued By: Safety and Sustainable Development Team
Project Name / Number: TJC3/32a : Calverley, R.Aire UB / 129564
For the attention of: All Scotland and North East

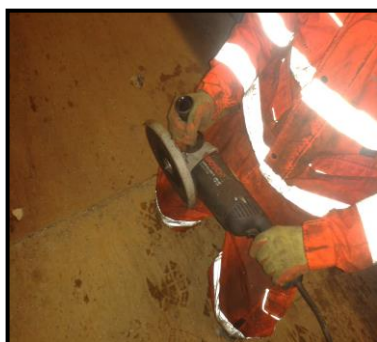
An operative sustained a leg injury whilst using a 9" angle grinder. Although the operative was holding the tool with both hands, the handle came away causing the body and blade to swing downward and cut through protective clothing and cutting the operative's thigh.

- The handle had not been fully screwed onto the body of the angle grinder.
- Pre use checks had not been carried out.

Always use equipment that is fit for its intended purpose.

- What tools are used on your sites and how would you know that they are fit for use through design, inspection, calibration etc.?
- Are you confident that operatives are carrying out effective visual checks before using tools?
- Where would you expect to find manufacturer's guidance for tools to support effective pre use checks?
