EVENT LEARNING

No.020

Incident Date / Time: 25th November 2014, 12:30 hours
Location: Low Buckholmside, Galashiels
Works Taking Place / Incident Type: Offloading sleepers from flatbed lorry / Accident Specified RIDDOR
Issued By: Safety & Sustainable Development Team
Project Name / Number: Borders Railway – Track / 129713
For the attention of: All Scotland and North East

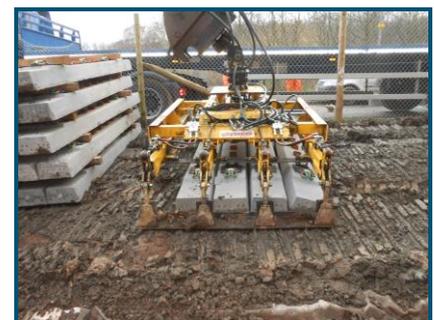
Concrete sleepers were unloaded from a flatbed lorry using a 4 sleeper spacer attachment which had been modified into a 5 sleeper grab. A member of site staff, acting as a slinger, was struck on the lower left leg by a sleeper when it fell from the grab resulting in a serious crush injury. The injured person subsequently had the lower part of his leg amputated.

Plant and Equipment: Two 5 leg sleeper grabs, sourced from a subcontractor, were actually modified 4 sleeper spacers. These sleeper grabs were subject to uncontrolled modification and were not fit for purpose.
