Thameslink Programme

**Train Conductor Shoe Damage Following Track Works on 17 June
and lessons learnt from IBJ failure on 27 May.**

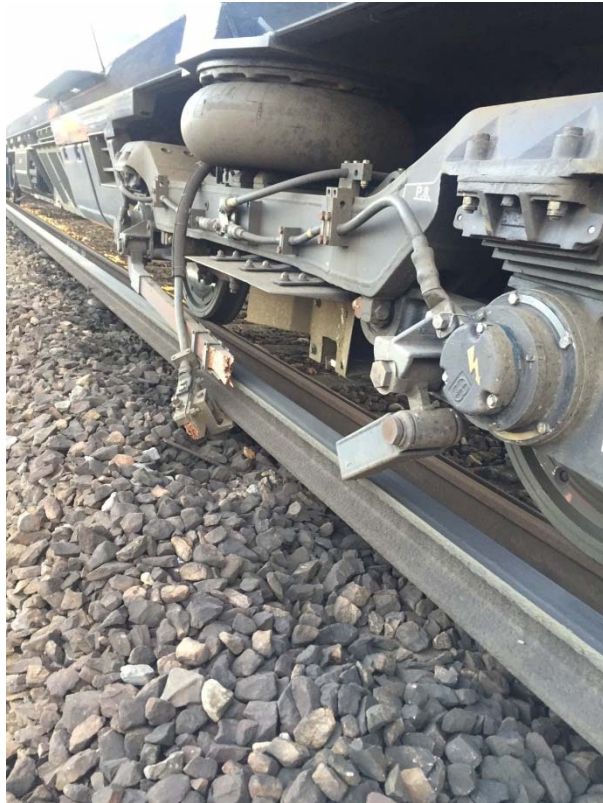
At 05.15 on 17th May following the hand back of a Thameslink Possession, the first passenger service travelling on the Up Charing Cross between Spa Road & London Bridge caught a traction cable with its conductor shoe.

- Where cabling or other track equipment is moved for protection, the person moving the equipment takes responsibility to make sure its re-instated before leaving the area
- As part of Track Hand back processes, there are robust plans in place to check and be informed where work has been carried out
- Consider highlighting all cables with paint to make them more visible to check
- Make sure all personnel are familiar and competent in working and understanding 3rd rail traction areas

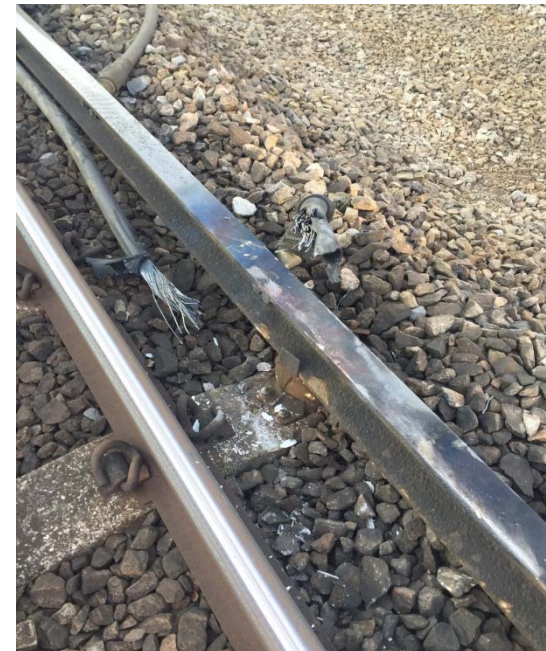
The cable was severed and left a stub sticking up in the air, which was then caught by a second train causing it to lose all complete conductor shoes and damaging the connector beam on four carriages and disabling the train. It appears the cable had been left sitting high on the ballast near to the conductor rail following work in the area.

This caused severe disruption to the morning peak services and lead to 71 train cancellations, further train diversions and 2124 delay minutes.

- ▶ BBR to review future site works and identify where jumper cables potentially intrude into the work 'envelope' and if appropriate cut back to reduce 'slack' (easy for jumpers, less so for transposition cables). All affected cables to be sprayed up to enhance visibility.

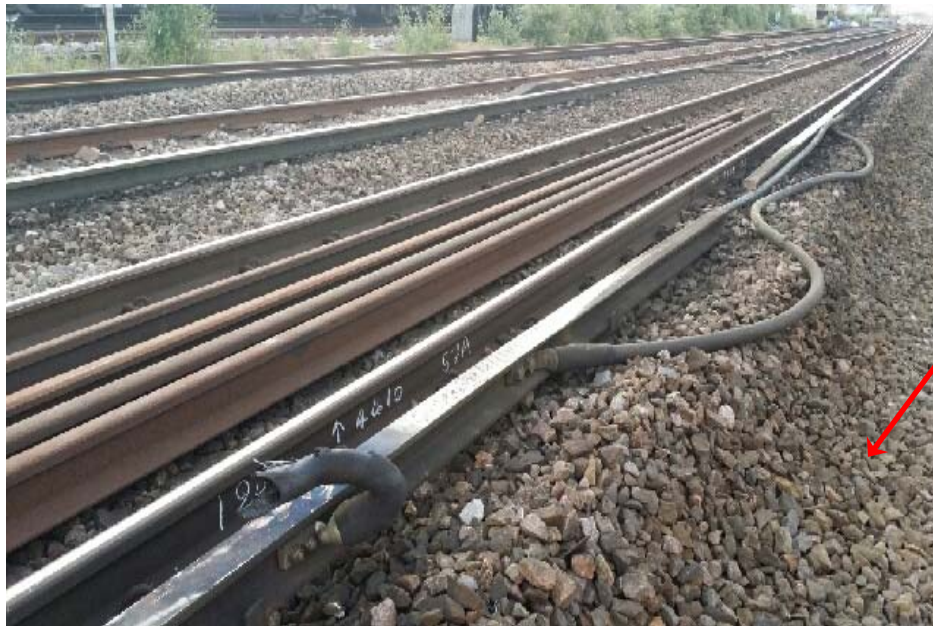
The investigation is underway and we know the cables were moved to allow the movement of tracked excavators along the ballast where a road had been removed
