Share with Pain

2 overruns @ Watford Week 6

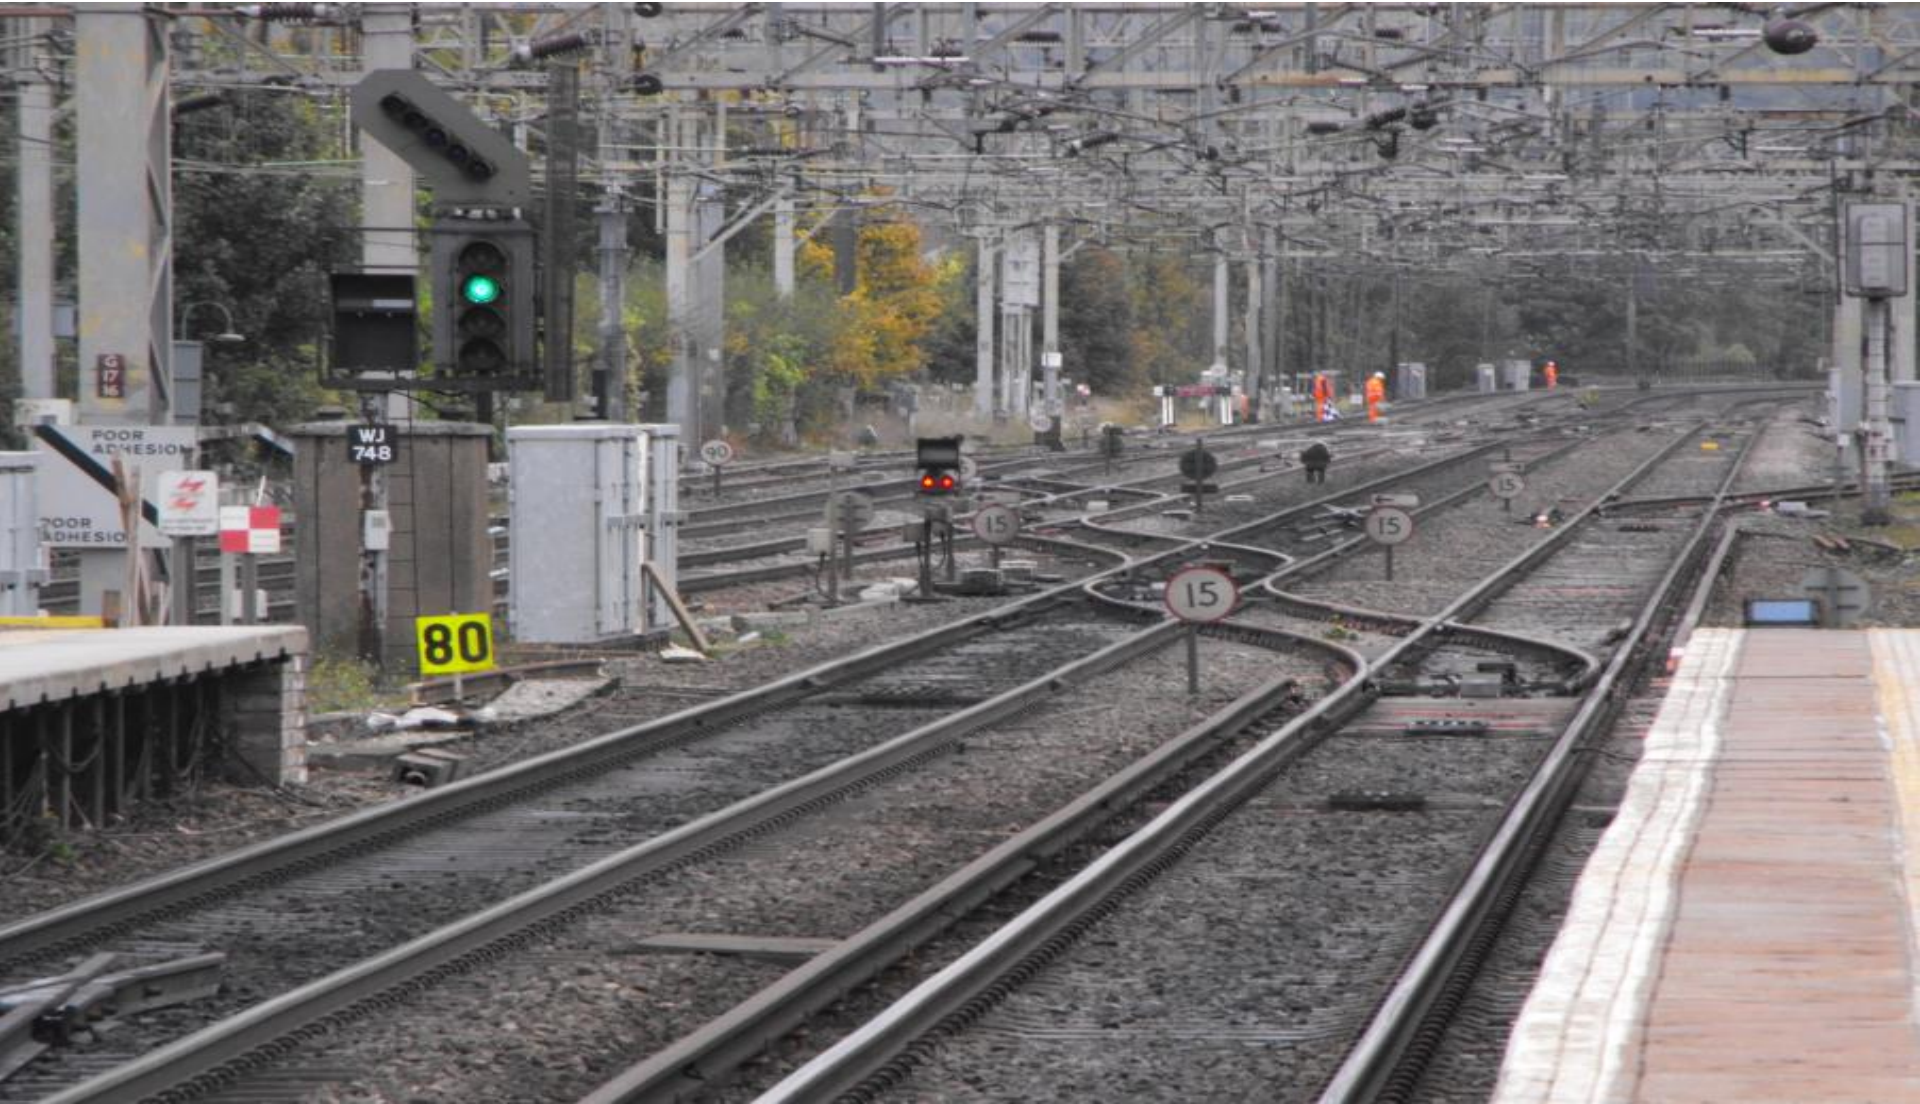
A long train of yellow tilting wagons is shown on a heavily canted track. The wagons are tilted at an angle, and the track is supported by concrete sleepers and gravel. Overhead power lines and support structures are visible above the train. The scene is set outdoors with trees in the background.

Operation of Tilting wagons on Heavily Canted Track

- Whilst attempting to unload S&C panels from the Tilting Wagons, the wagons were positioned at a pre-planned location where the track was heavily canted. This heavy cant led to the inbuilt safety system engaging to prevent an unsafe release of the locking mechanisms, so wagons couldn't be tilted to enable unloading

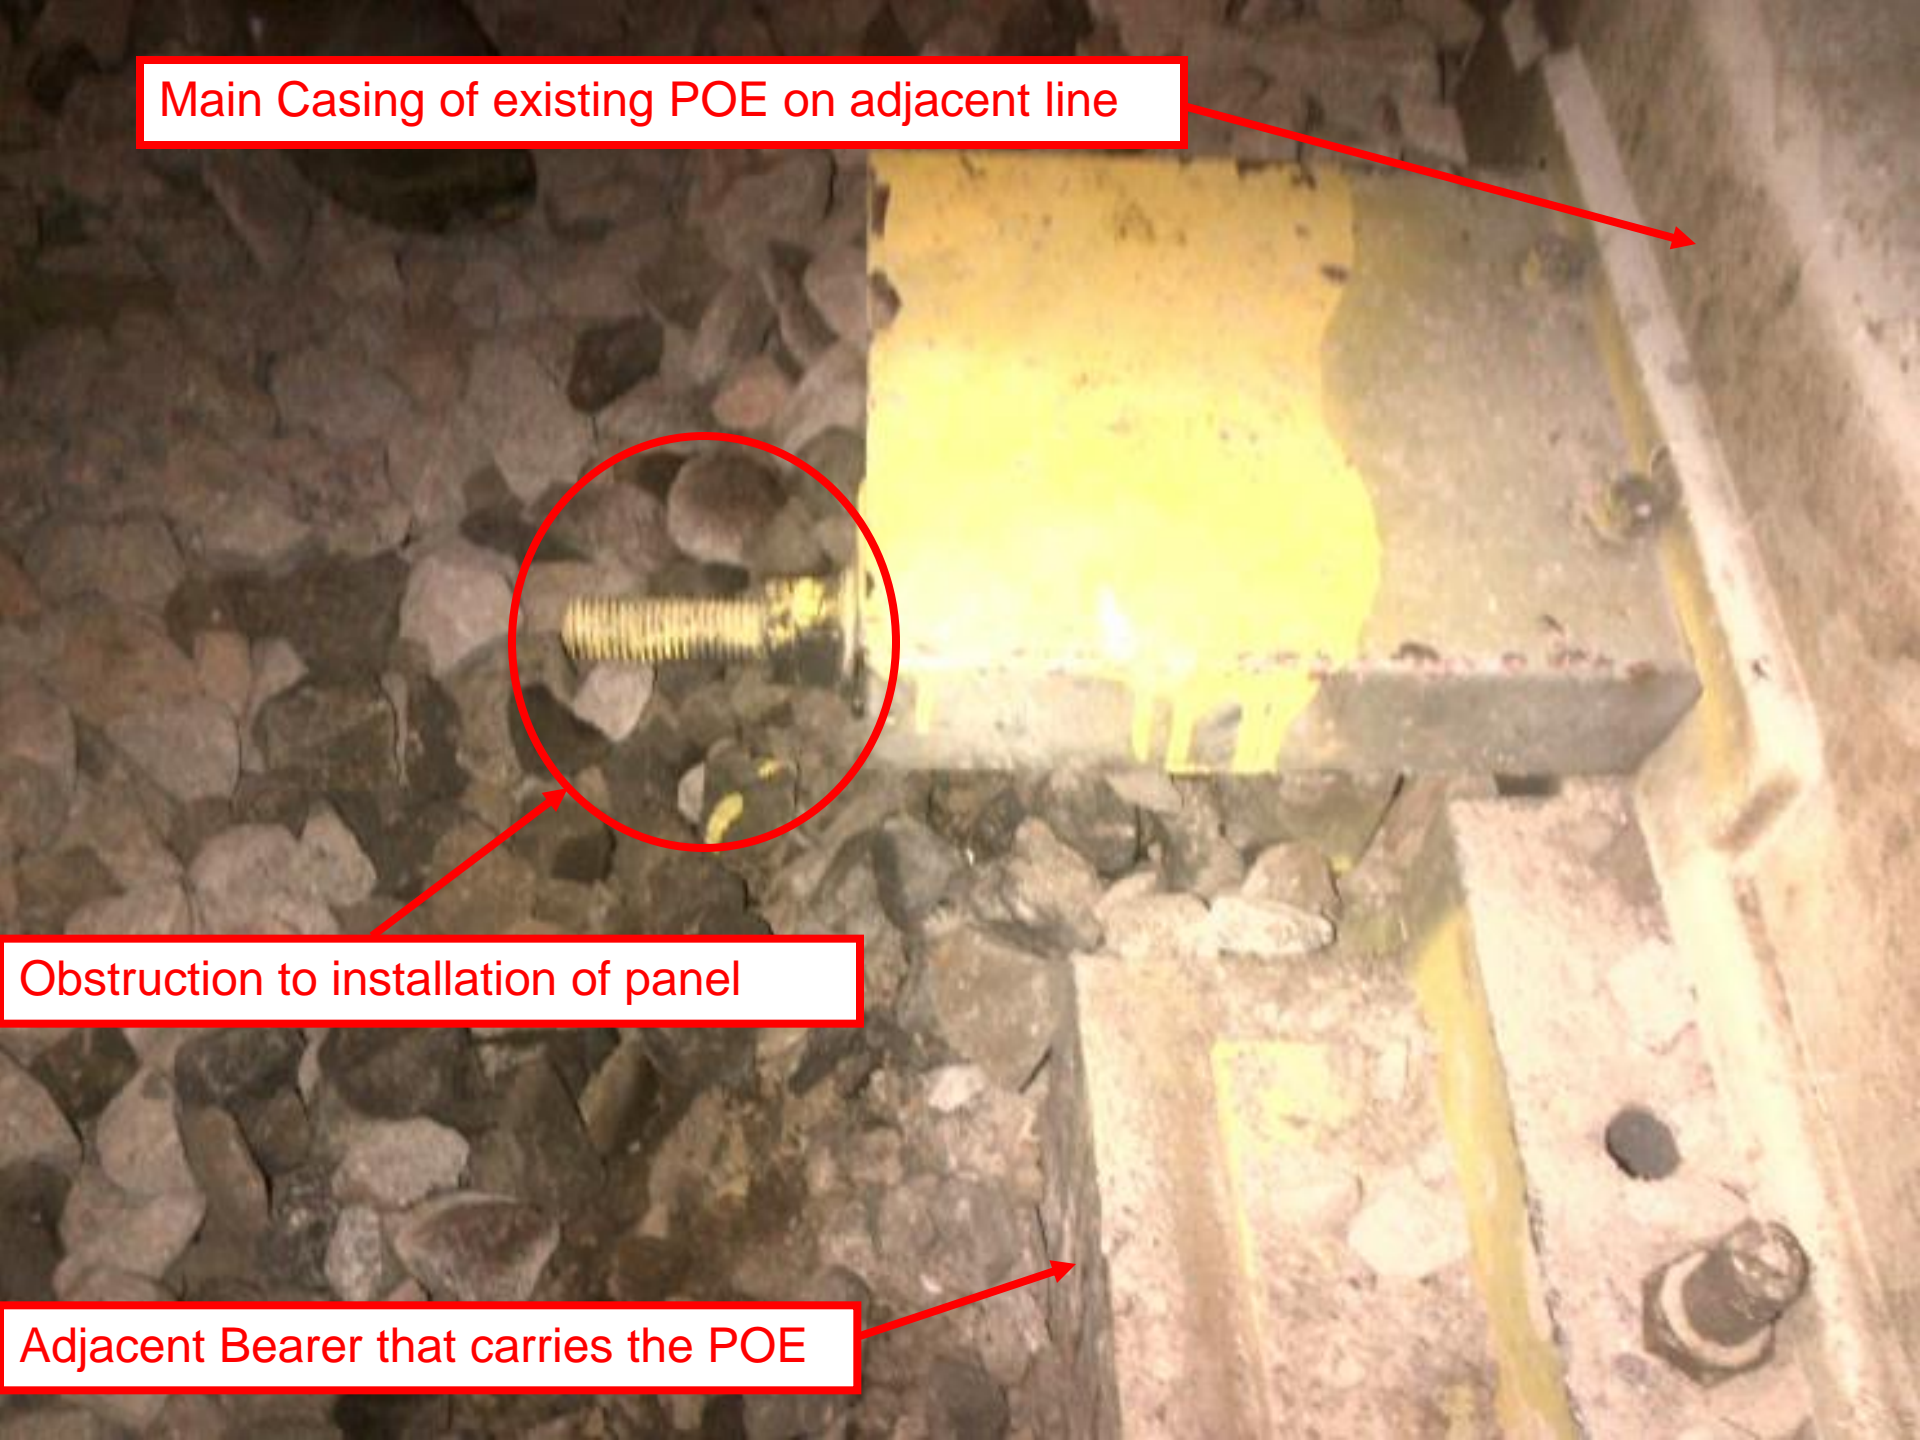
POE On adjacent Line Preventing the installation of one of the S&C Panels

Main Casing of existing POE on adjacent line

Obstruction to installation of panel

Adjacent Bearer that carries the POE

- When installing S&C Panels, the Points Operating Equipment on the Adjacent Line (Down Slow) prevented the installation of one of the new panels
- It wasn't the Main POE Body or the Bearer carrying the Existing POE that Prevented the installation, but the Rodding that protruded from the POE
- New Concrete Bearers had to be trimmed to allow the installation of the panel. We still have to decide whether these bearers have to be replaced
- Two hour delay to the installation of the panels as decision around mitigation had to be made and plant had to be positioned for the mitigation to be undertaken
- This was an oversight in the design checking process, albeit the Bearer and the POE Casing wouldn't have caused the issue. The change of footprint and multi staging was a contributory factor to this issue

Action:

1. On all Multi Stage Works, the whole of the POE must be considered as the Existing Footprint and not just the casing and bearers
2. Retrospective check to be undertaken by designers to see that this isn't an issue elsewhere, particularly on Multistage/Complex works where adjacent lines are left clipped out of use until subsequent stages similar to Watford.

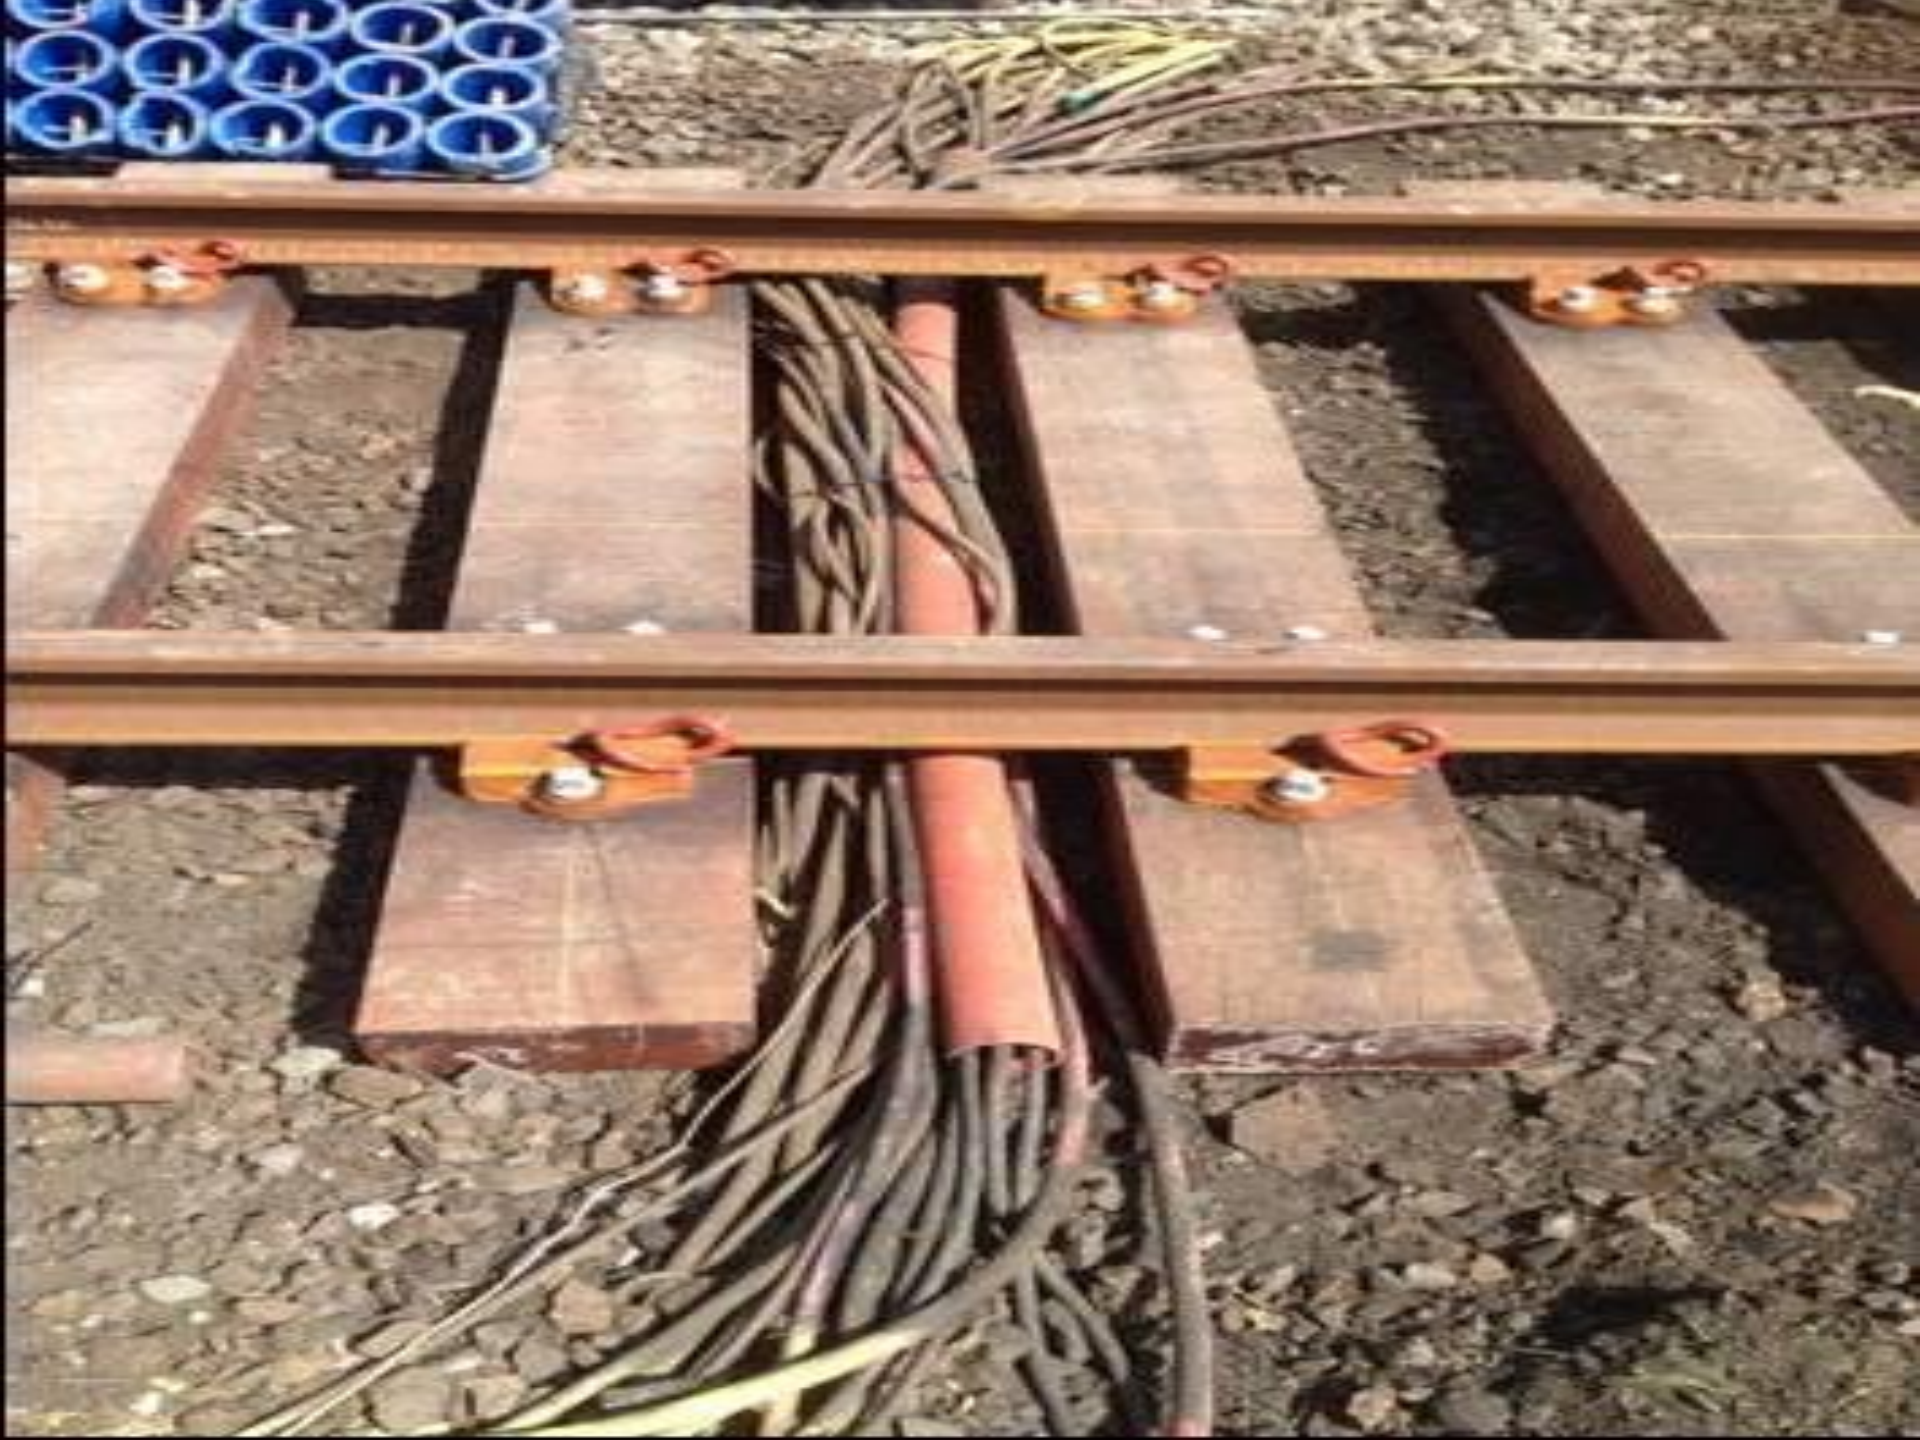
Unforeseen Buried Services (DC Line)

- Failure in AMP and CDM Process as Unforeseen Cables in four locations (see attached photograph). This is under investigation as was a significant issue for both Time and Risk.

A photograph showing a trench filled with a large bundle of buried cables. The cables are bundled together and run parallel to a concrete curb. A worker in orange safety gear is visible in the background, standing on the asphalt surface. The ground is dark and appears to be a construction or utility site.

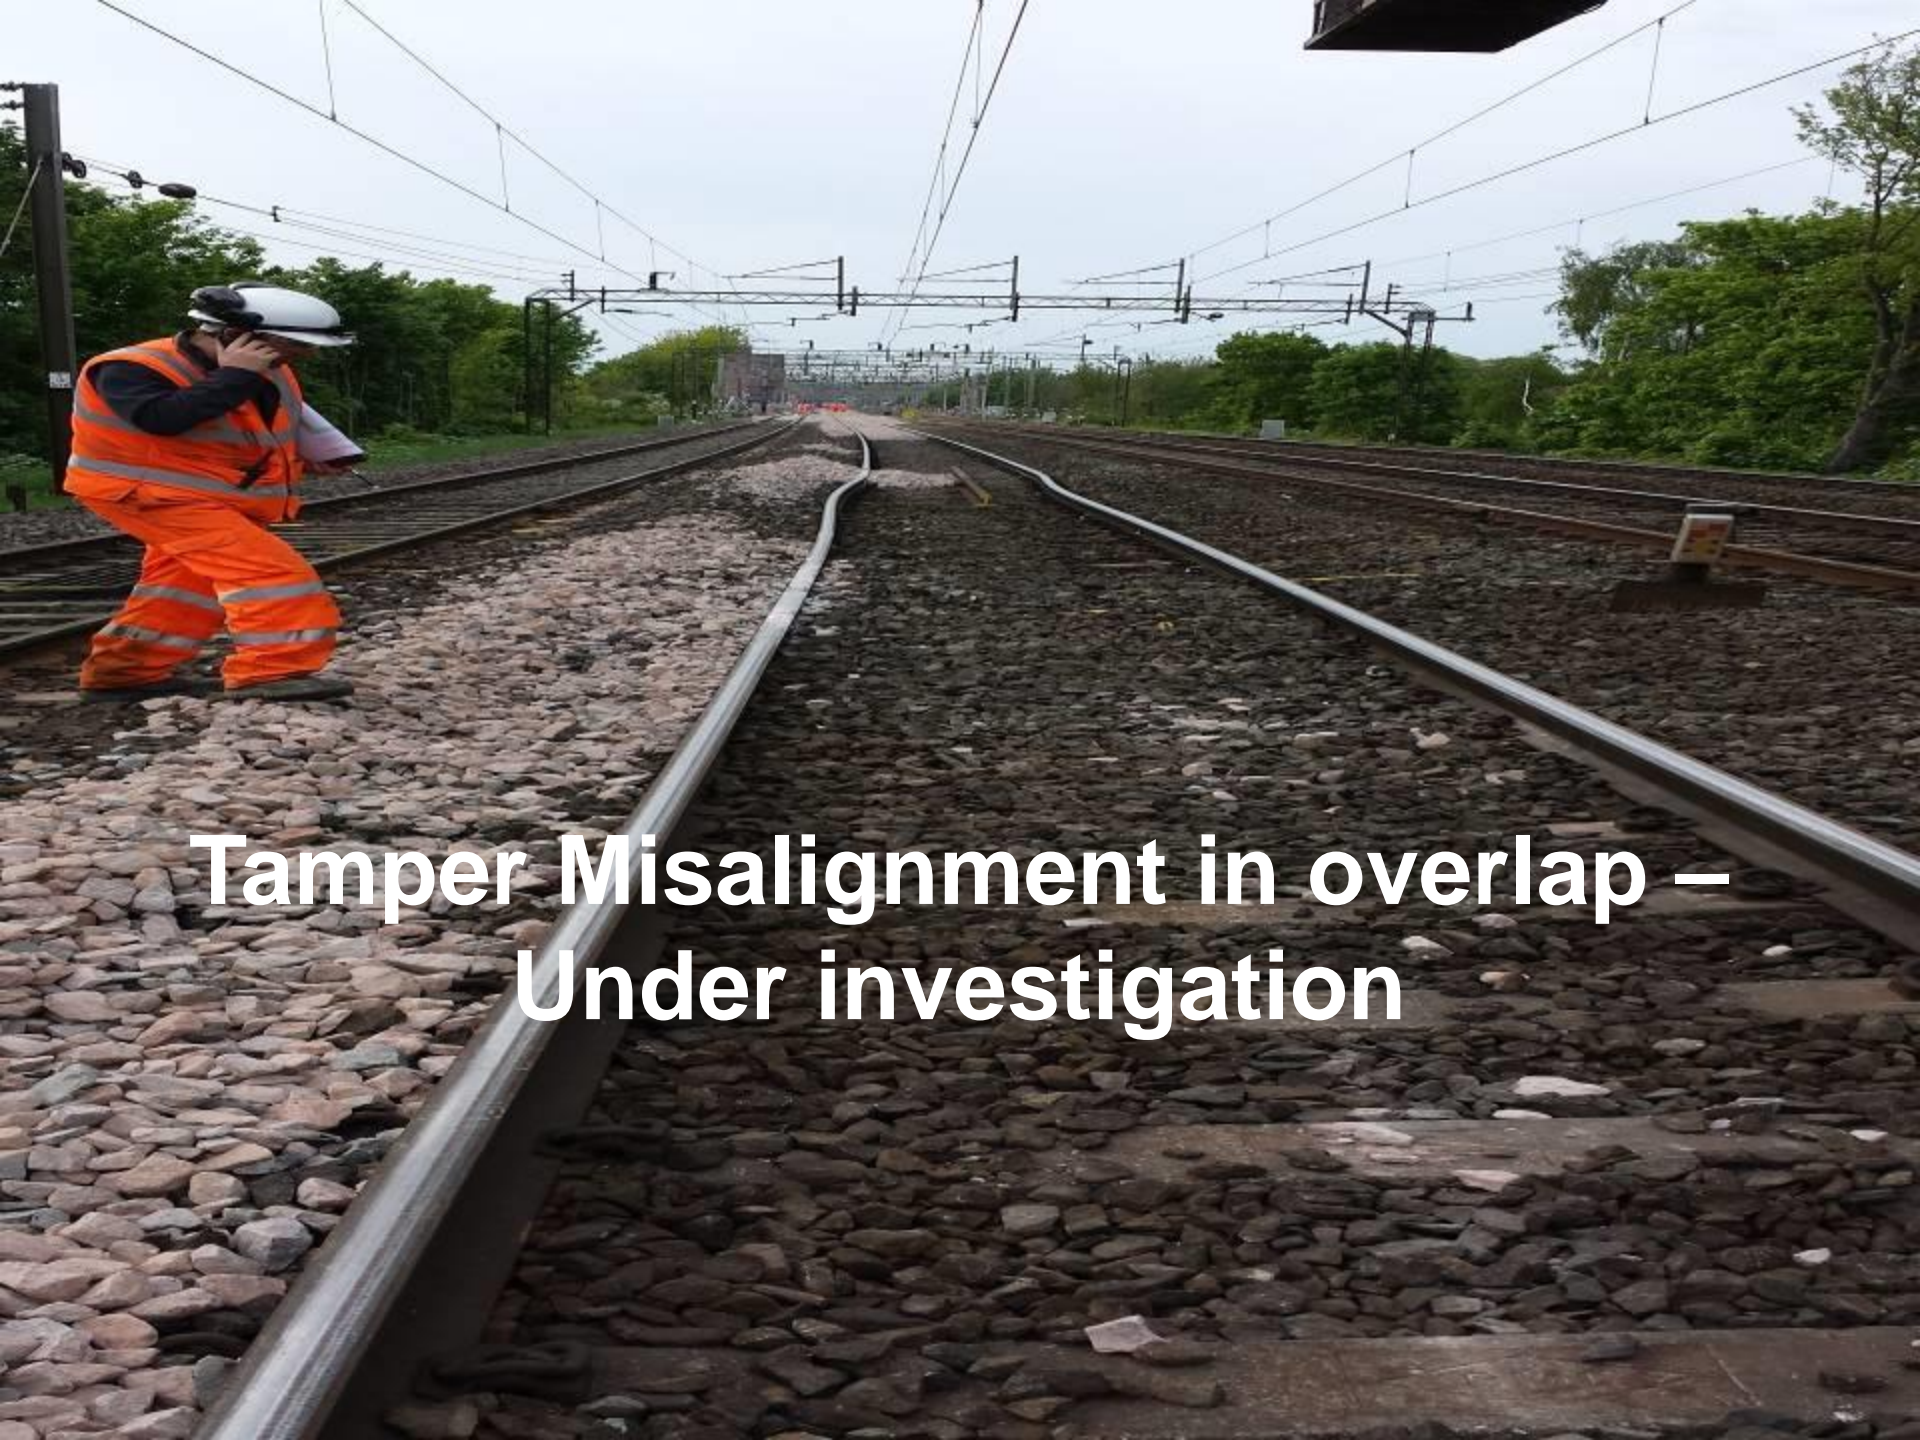
**Tamper Misalignment in overlap –
Under investigation**

- Failure of Auto ballasters
- Change of Methodology due to ALO Guidelines as plan slipped significantly
- Tamper Trolley Derailment Causing a 125mm Misalignment which had to be removed, delaying agreed wheels free time on the Up Fast(see photo)
