Lessons Learnt from a Significant Event

Issue Number: TLP002

Title: London Bridge Station Redevelopment, GRP Tower Collapse – 28th Nov 2012

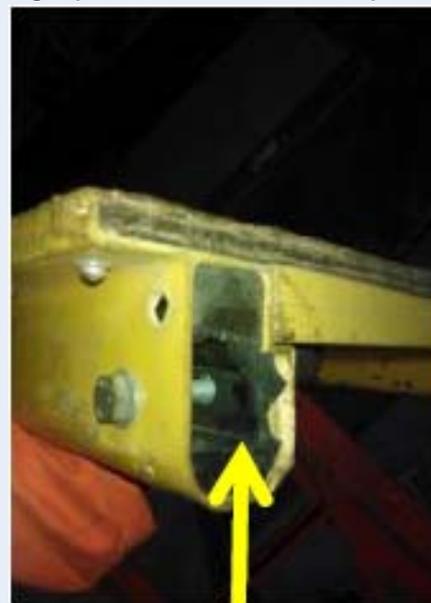
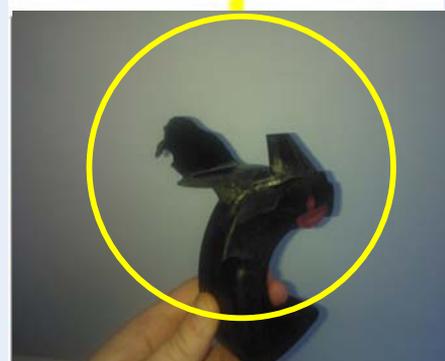
Pictures(s)

Two operatives were working from a Glass Reinforced Plastic (GRP) Tower, erecting high level lightweight formwork panels. During this task the working platform of the GRP tower gave way. One of the Platform claws (see picture), that connects to the 4 rung end frame sheared and broke off.

The platform did not completely fall off but did twist with the weight of the operatives who were working from the platform. The operatives managed to hang on to the edge protection and did not fall from the tower. One operative got his knee caught between the twisted platform and the diagonal brace however no injury was sustained.

Photographs show the failure points

The tags were removed from the GRP towers and all works on GRP towers around site were replaced with alternative access equipment. The manufacturer collected the GRP tower for inspection, however to date no information has been received from them on the failure causation.

- Equipment Selection / WPP / Task Brief – it was not necessary to use GRP Towers, Aluminium Towers or Mobile Elevated Work Platforms (MEWPS) could have been selected, however the exact type was not stipulated on the WPP or Task Brief.
- Equipment Ownership / Management – it was not clear who owned the equipment and it was not clear whether the mandatory Provision and Use of Work Equipment (PUWER) inspections had been undertaken for the tower.
- Inspection Process – following previous events the daily inspection process agreed had not been followed, however it was considered the visual inspections would not have identified damage / fault inside the component.

- GRP access equipment is **not** to be used on the Thameslink Programme unless it can be demonstrated by risk assessment that alternative access equipment would not be suitable for the task. In such instances usage must be endorsed by the relevant Network Rail Project Director.
- Plant / equipment ownership on site to be reviewed to ensure the necessary inspections are being undertaken
- WPPs / Task Briefings should where practicable be specific on the access equipment to be used on site
- Preservation of evidence is critical to understanding equipment failure
- Whilst the combined weight of the two operatives and equipment were within the safe working limits of the platform – the combined weight of equipment / persons and type of activity should always be considered when selecting access equipment
