Issued By: Thameslink Programme, HSEA Team, James Forbes House, 27 Great Suffolk Street, London SE1 0NS

Issue Number: TLP 021

Title: Mill Hill Broadway Station, Polythene bag removal from Over Head Line, 10th March 2014

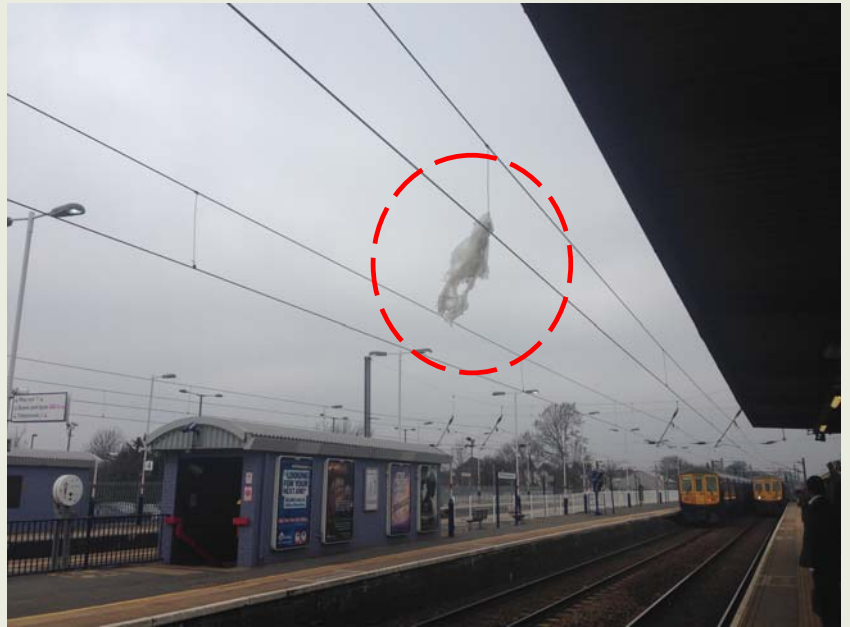
A suppliers employee was waiting at Mill Hill Broadway after completing works at another location. As he waited on the Platform he noticed that a Train was stopped outside the station due to Polythene that had become lodged on the Over Head Line (OHL). Following a discussion with the train driver, the employee used a wooden hook switch pole to remove the polythene from the OHL without there being an isolation in place.

Photo: Polythene bag on the Over Head Line

- Never work with or around live equipment unless the work has been planned and an isolation is in place.
- Always have a valid permit to work where required
- Never undertake an activity unless you have been trained, assessed as competent and have the right equipment and controls in place
- Consider your own actions before trying to be a hero – do not, under any circumstances put yourself at risk
