Shared Learning

The Thameslink Programme Issue Date: 12th August 2015 - For further info contact declan.keane@networkrail.co.uk

Issue Number: TLP035 Title: Possession Irregularity (1st May 2015)

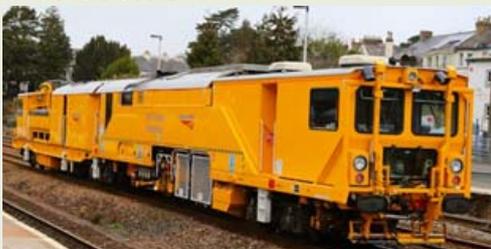
Diagram/ Photo of event:

A stone blower (a railway track maintenance machine) operated by a third party, entered the Up Sidings North within the Horsham sidings. The approach of the stone blower was observed by a Carillion Banksman who was banking for a 20t excavator working on an excavation adjacent to No 2 sidings.

Visibility at the site was good and the Banksman stood the excavator down before the Stoneblower, travelling at a walking pace, approached the adjacent worksite. At no time were operatives on the ground exposed to risk.

A stoneblower

- **Local Arrangements:** The local arrangements were subject to a detailed review and all interfacing parties were involved. Particular emphasis was placed on (a) clarification (physically marking) the location of the PLBs and their proximity to open lines and (b) the process for signing into the sidings by the COSS.
- **Interface Meetings:** Fortnightly interface meetings have been set up, where all interfacing parties are invited and attendance is mandated (Thameslink and non Thameslink suppliers). All parties can discuss the upcoming scope of planned works and detail the planned train movements within the depot.
- **Briefing Pack:** A briefing pack was developed to explain the local arrangements (using photographs and diagrams) and the local procedures to ensure that all of those responsible are fully conversant with the process and why the protection arrangements are in place.
