Shared Learning

IP East Midlands Region

Dislocated Elbow - Hucknall

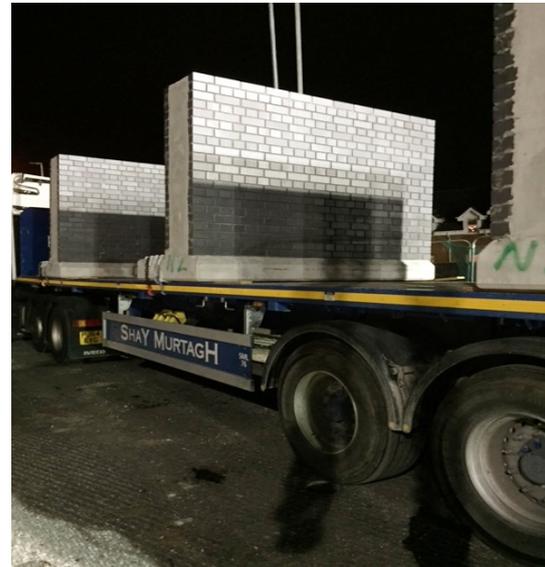
On Sunday 28th August a Baldwin's slinger/signaller at the Station Road Compound in Hucknall sustained a serious injury to his left elbow whilst checking the weight of an 'L' shaped parapet on the back of a flatbed trailer.

- A 500 tonne telescopic mobile crane was being used to lift parapets onto the newly constructed bridge deck.
- The lift supervisor requested that the slinger (via radio communication) check the weights of the parapets on the back of the flatbed trailer, positioned west of Station Road Bridge, RAC/20A.
- The slinger accessed the bed of the delivery trailer on the northern side to ascertain the weight of the 'L' shaped parapet and relayed weights to Lift Supervisor.
- The Slinger knelt down on the flatbed trailer near to the edge and as he stood up lost his footing and fell to the ground, circa 1.6m.
- The slinger was offered first aid on site and then taken to Queens Medical Centre Hospital, Nottingham where a dislocated and closed fractured left elbow was confirmed.

Always use a safety harness when working at height, unless other protection is in place.

- The slinger did not need to access the bed of the delivery trailer.
- Never undertake any job unless you have been trained and assessed as competent.
- Clear communication between the lift supervisor and slinger is essential, the slinger was unsighted.
- Fatigue was not managed effectively, which may have contributed to the accident.
