## Runaway of Permaquip 'B' type personnel trailer

**Ref:** NRB 17/11

**Date of issue:** 20/06/2017

**Location:** Hope, Derbyshire

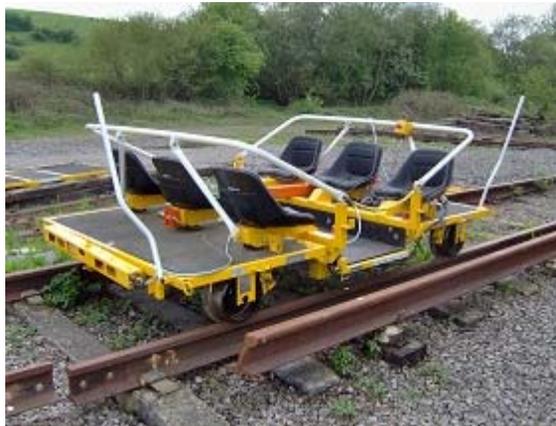
During a Network Rail LNW North possession on the evening of Saturday 28 May an incident occurred involving a Permaquip Gator Road Rail Vehicle (RRV) and a 'B' type personnel trailer.

Subsequently, the section manager who was also the ES made a decision to send the machine and trailer to Bamford to facilitate off tracking the vehicle and trailer within the possession time. A strap was applied that disabled the trailer brakes.

During that seven mile journey, with the Gator propelling the trailer, the trailer became detached and ran away for some 1 ¼ miles within the possession before coming to a stop on a set of points. Other staff had been working at those points earlier in the shift.

- How should the brakes on RRVs and trailers be tested during on-tracking and before uncoupling from an RRV?
- What action should you take if the brakes do not operate as expected?
- What should happen with the coupling pins and locking pins before a RRV and trailer are moved?
- When you take over the operation and control of an RRV and trailer how do you ensure the brakes are working correctly?
- If you became aware of any defective equipment being used in your work area, what would you do?
