The Thameslink Programme Issue Date: 14th December 2016 For Further Info Contact mike.netherton@networkrail.co.uk

Issue Number: TLP 067 Title: Tamper Cable Strikes

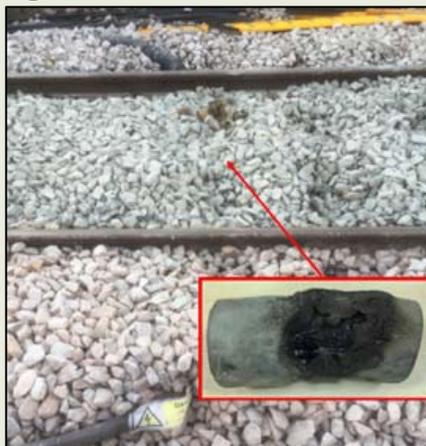
1st Cable Strike

On the 12th of October a whilst tamping a new road in the Bermondsey Dive Under area a Tamper struck a buried live 750v traction supply cable. The cable was just under the ballast surface and was pierced by the tines as they were dropped within the ballast causing significant sparks and flame.

- A review of the process used for hazard identification and communication as part of work planning
- Re-briefing and site audit of procedures relating to tamping around live cables
- Implementation of a 'Permit to Tamp' process
- Establish criteria that will determine the level Tamper Operator competency required to tamp in areas where cross track cables are present

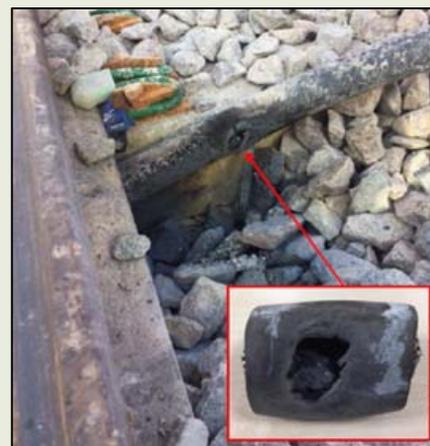
2nd Cable Strike

Tamping re-commenced but part way into the task the same cable was drawn back onto a sleeper by the tines and the insulation compromised leading to the cable burning out.
