Safety Bulletin

Trolley operator receives broken arm

Ref: NRB 17/16

Location: Culham Station, Western Route

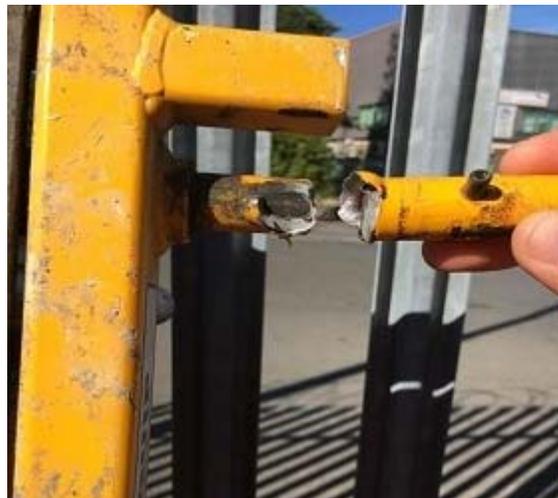
The brake handle then gave way when a weld on the brake lever failed which resulted in the first worker falling heavily and banging their arm on the trolley.

The trolley was quarantined and is awaiting the report from the equipment supplier as to the cause of the equipment failure.
