# Shared Learning

## Lost Time Injury from Twisted Ankle at Blackpool

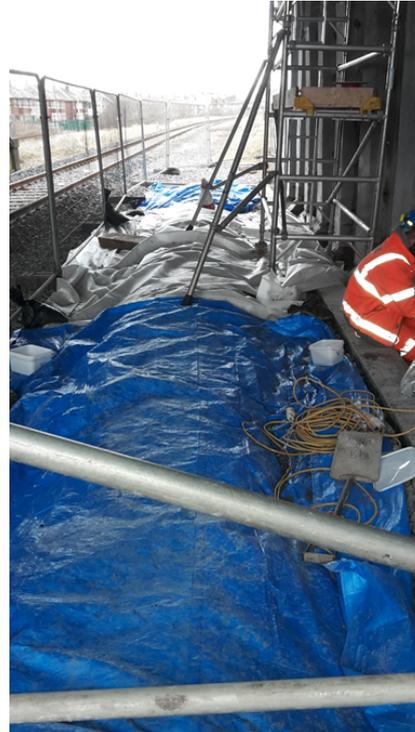
The tower scaffold used to access the work was positioned adjacent to a redundant ballast shoulder which meant that the access and egress from the tower was directly onto it. Due to the nature of the work area, the team were briefed that the ground was uneven and possibly slippery. This briefing was given as part of the task brief, the daily hazards brief and as part of the site induction.

The reason that the ballast was covered in visqueen, was to protect it from further contamination during the hydro demolition works.

From the picture you can see that there are many hazards that could cause a trip or a fall. Have a look to see how many there are but more importantly ask the question why haven't these been identified and suitable controls applied. Is it because we do not challenge the way we work enough or are we becoming more accustomed to hazards?

Identify these during the initial site walkout and pass them on to the designer so that they are considered during the design phase. In this particular case the ballast shoulder was redundant and could have been levelled off.

This should focus on the protection of the individual in the first instance rather than the asset. We actually introduced a hazard by putting down the visqueen.

When carrying out monitoring activities you must speak to the individuals that are working in the area, more often than not they will tell you what the issues are.
