Failure of main hoist rope on mobile crane

Ref: NRA 18/02

Location: Blackpool North Depot

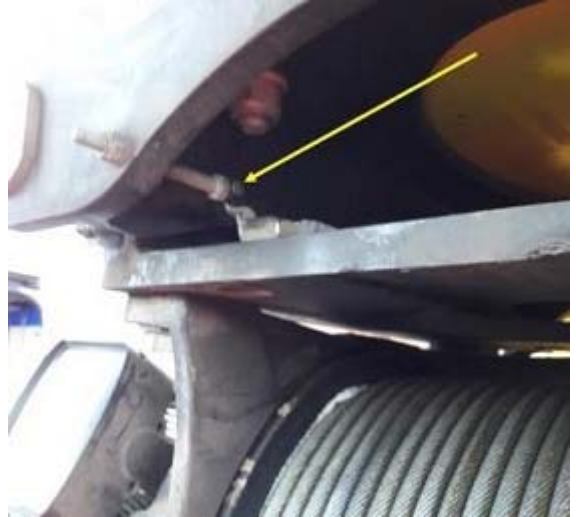
An initial engineering inspection of the three other RRV cranes in the TXM fleet has been undertaken. Functional checks on the boom telescopic function revealed none of the three will extend when the safety switch (as shown in annotated photograph) is activated. This is a safe condition.

The RRV involved in the incident has been identified as not functioning correctly: the safety switch does operate when the boom is retracted but not when extended. This is an unsafe condition which is thought to have existed since upgrade and crane modifications. Operators do judge the rope tension during operations and this may be why the failure mode has not been revealed during use earlier.

- Owners and operators of similar equipment shall arrange for the operation described above to be replicated under safe conditions to check whether the interlocking device fails to operate safely.
- Equipment that fails this test should be quarantined.
- Network Rail Construction Managers and supervisors should carry out a review of lifting equipment on their sites. Where any potentially affected equipment is identified they should check with the POS Representative that this test has been undertaken.
- Construction Managers should then confirm back the results of these checks to their Programme Directors.
