Safety Advice

Failure of swivel hook

Ref: NRA 18/03

Date of issue: 12/03/2018

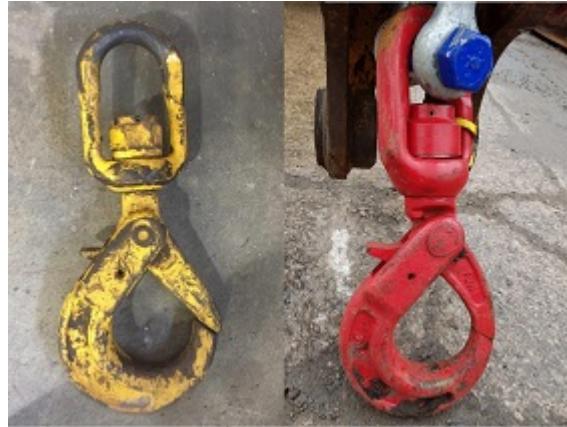
Whilst unloading one tonne ballast bags using an RRV and bag lifter the castellated securing nut on the lifting hook worked free and became detached from the coupling ring. The hook and bag lifter had been used several times within the shift, however as the Crane Controller attached the bag lifter to the next bag of ballast, and instructed the Machine Operator to lift the bag, the castellated securing nut came off and the hook separated from the RRVs boom.

The investigation has identified the failed hook is similar to the yellow one shown in the LH picture above. This has a castellated securing nut with a bronze bush and is NOT designed to be rotated with a load suspended.

The red hook in the RH picture has a ball bearing swivel and can be rotated with the load suspended.

Crane controllers and Machine Operators are to ensure they recognise the type of lifting hook fitted. If they have a lifting hook with a castellated securing nut the load should not be rotated whilst it is suspended.

- Prior to commencing lifting operations Crane Controllers and Machine Operators must satisfy themselves that they recognise which type of lifting hook is fitted, and its correct method of use.
- The plant hire company involved has instigated a campaign change of all hooks on their machines.
