Safety critical failures of link trolley brakes - Issue 2

Ref: NRA 18/05

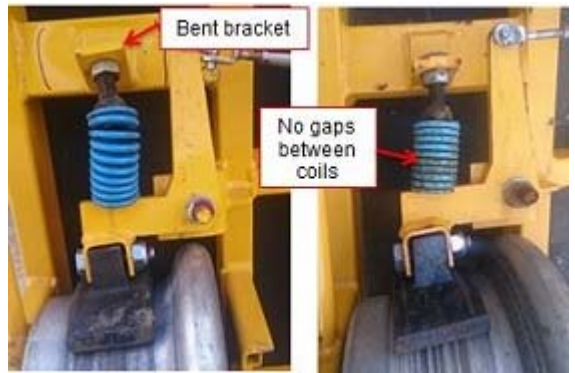
Inspection of the link trolley fleet at Northampton Bridge Street Depot during 2015 found three out of eight units to have brake systems that had failed. Further investigation with Torrent Trackside identified evidence of other trolleys returned for maintenance with similar failures.

The right-angled bracket, which is welded to the frame and holds the brake spring in place, was bent away from the wheel. This reduces the brake force and increases the risk of runaway.

- Link Trolleys shall not be used on gradients greater than 1:150 until further notice from the Head of Plant.
- The restriction applies to Link Trolleys only due to the failure mode pictured above.

ALL Trolleys shall undergo a pre-use check on each occasion of use. If any of the following damage is present on Link Trolleys, they shall be quarantined:

1. Bent bracket holding the spring in place.
2. Coil Bound spring (no gaps between each coil).
