# Safety Alert

## **Serious staff injury following collision in a worksite**

**Ref:** Alert 18/01

**Location:** Calveley, between Crewe and Chester

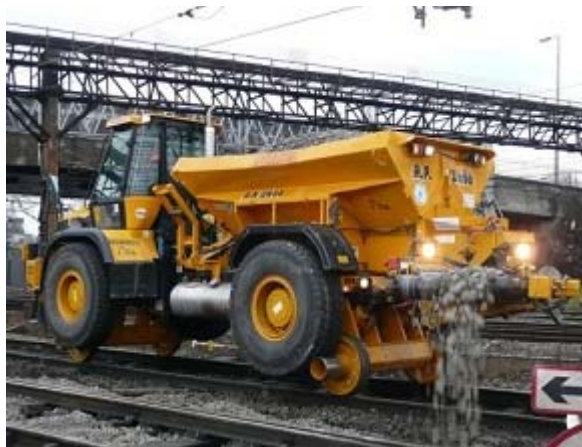
In the early hours of 19 September 2018, a Super Boss Ballast Regulator collided while traversing at speed, with the rear of a Kubota personnel trolley and caused the derailment of the latter.

The two rearmost Network Rail employees being transported were injured. One employee suffered a shoulder injury, his colleague suffered serious injuries to both legs and had to be stabilised on site before being taken to a specialised trauma centre, where he underwent surgery.

All staff working in worksites with plant movements must be briefed that:

- All plant movements within worksites must be undertaken at 5mph or less.
- Where visibility may be an problem, the machine Controller must be on the ground supervising the move and the exclusion zone.
- All staff must be clear about how plant movements are to be physically separated so as to prevent the possibility of collision.
